Hydro-geomorphic hazards and impact of man-made structures during the catastrophic flood of June 2000 in the Upper Guil catchment (Queyras, Southern French Alps)

Gilles Arnaud-Fassetta*, Etienne Cossart, Monique Fort

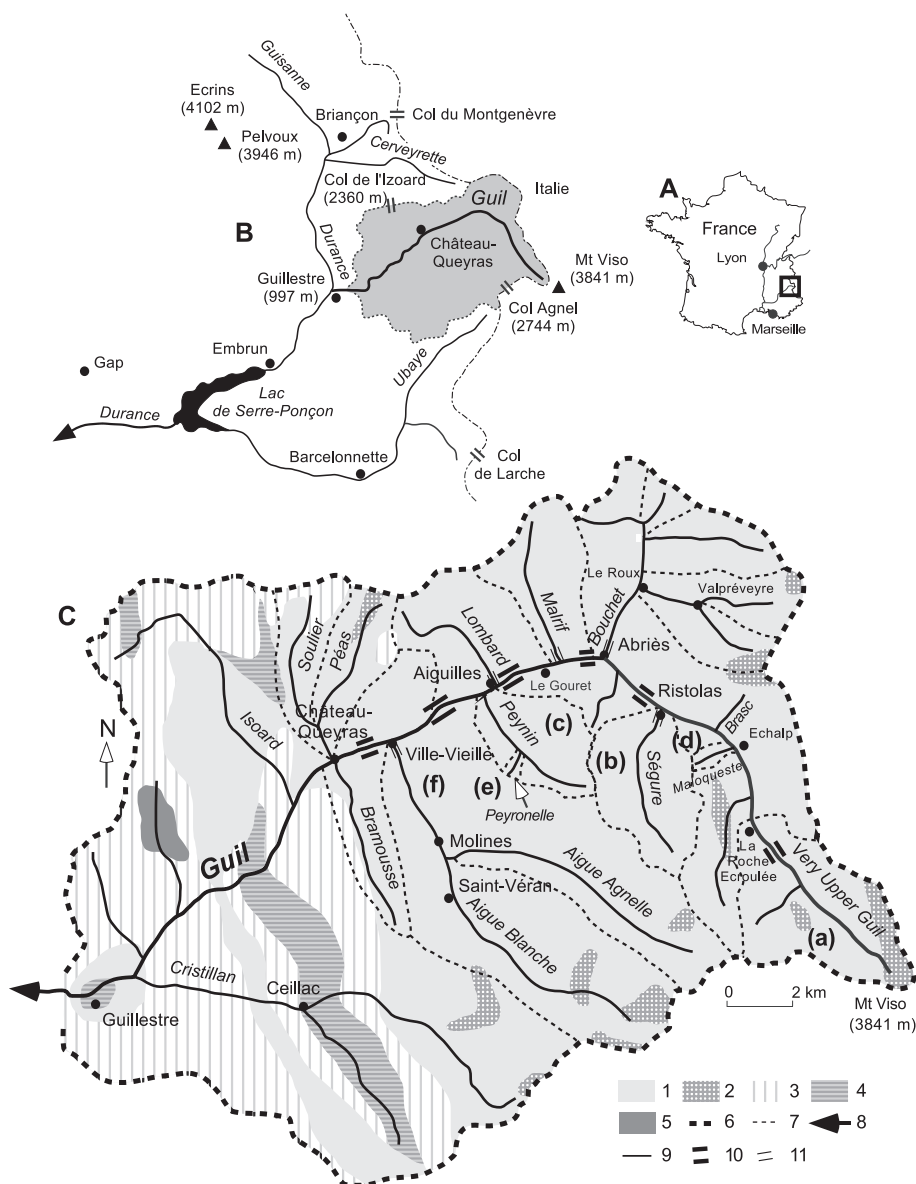
Fig. 1. The Guil River catchment. (A) General location and (B) location of the Guil basin in the Durance catchment. (C) The study site corresponds to the part located upstream Château-Queyras. Lithology: 1=schists “lustrés”; 2=ophiolite complex; 3=limestones and dolomites; 4=sandstones and conglomerates; 5=flyschs. Hydrography: 6=limit of the Guil catchment (317 km² upstream Château-Queyras); 7=subcatchment divides (a=26 km², b=16 km², c=15 km², d=0.94 km², e=0.41 km², f=98 km²); 8=Guil River; 9=main tributaries of the Guil River; 10=gorge section; 11=channelised stream.

Located in the southern French Alps, adjacent to the Italian border northwest of Mt. Viso (3841 m), the Guil River, a left bank tributary of the Durance River, drains a 730-km² catchment (Fig. 1). Elevations range from 897 m to over 3300 m.

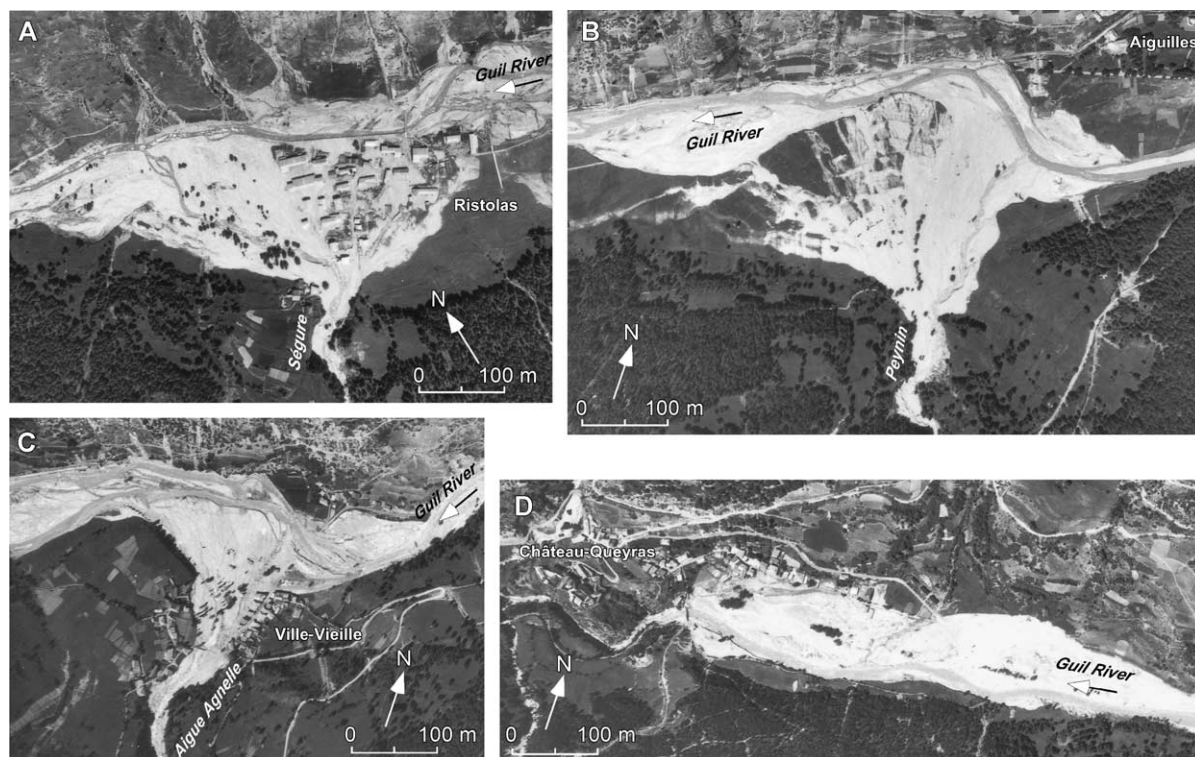
Fig. 2. Selected sites displaying the impacts of the 1957 flood at the main confluences between the Guil River and its tributaries. Note sediment accumulation on alluvial fans and channel widening along the Guil River, occupying its entire floodplain. (A) Guil/Ségure confluence, Ristolas fan (1604 m); (B) Guil/Peynin confluence, downstream of Aiguilles (1456 m); (C) Guil/Aigue-Agnelle confluence, Ville-Vieille (1379 m); (D) Château-Queyras, damming effect upstream the gorges cut into the rocky glacial knob of Château-Queyras (1328 m) (IGN aerial photographs).

triggered landslides and provided huge quantities of material to the valley bottom. Many log jams accumulated at the narrow sections; these effectively dammed the river for a while until outburst flood-waves occurred, which, in some places, were powerful enough to move very large boulders (Tricart, 1961a, referred to ophiolitic green boulders, 2-m long and exceeding 10–15 tons in weight at Ville-Vieille). The peak discharge probably reached $315 \text{ m}^3 \text{ s}^{-1}$ at Aiguilles (Koulinski and Lefort, 2000). Many parcels of land were washed away; for instance, in Aiguilles, about 50 ha of crops and meadows were lost and 500 m^3 of woodland was destroyed (RTM). Strong sediment depositions were observed on alluvial fans of the Guil tributaries (Fig. 2). In the Château-Queyras area, the Guil floodplain was entirely flooded. A temporary lake was formed after the obstruction of the gorges and considerable aggradation was observed (estimates $>1,000,000 \text{ m}^3$; Tricart, 1961a) (Fig. 2D).

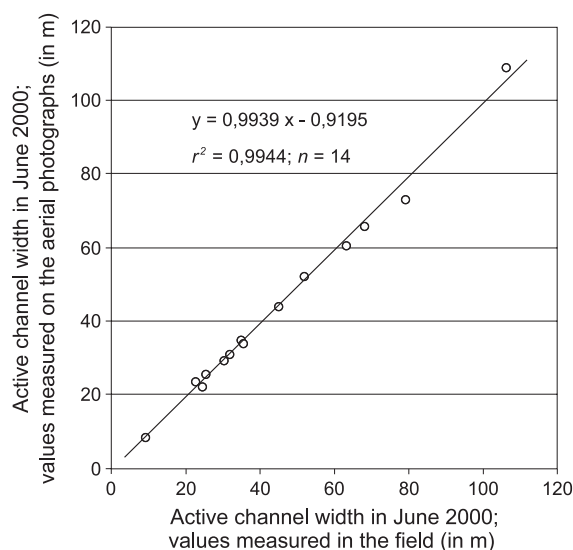
Fig. 3. Correlation between measurements of the active channel width deduced from field surveys and from aerial photograph measurements.

In order to compare the respective impacts of the June 1957 and June 2000 floods, we analysed several sets of air photos for different dates, before and after the floods, namely: June–July 1956 (IGN; A23/3537–3697; 1/25,000 scale), June–July 1957 (IGN; FR-086/150; 1/15,000 scale), June 9–22, 1999 (IGN; FD05/250; 1/25,000 scale), June 16, 2000 (RTM; AERIAL 08-00.1266/732; 1/8,000 scale). Scanning and geometric rectification of photographs were first performed. Photo analysis was then carried out in two ways, firstly for specific site studies and geomorphological mapping, secondly for systematic analysis of the effect of the floods on active channel width and, of the impact of engineering works on the channel response. Eighty sites were selected at regular intervals (every 250–300 m) along the river course. The total length studied amounts to 23 km, which corresponds to the entire Upper Guil River with the exception of the first 5 km, not photographed in 1957. We measured the “active channel width” (Osterkamp and Hedman, 1982), the portion of the alluvial landscape composed of active, unvegetated gravel bars and low-flow channel(s) as defined by Rundle (1985). The compared measurements of active channel width from aerial photos and the field give a very good correlation between the two methods (Fig. 3).

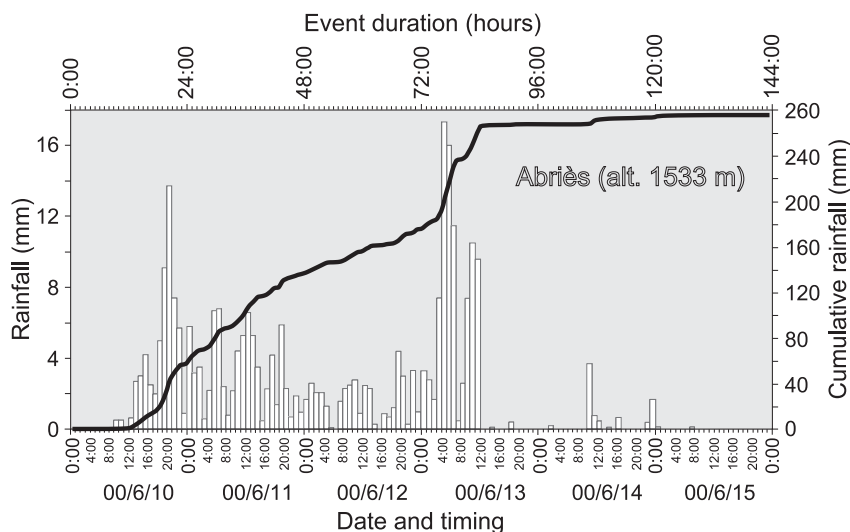
Fig. 4. The June 2000 meteorological event, Abriès station (1536 m), where the cumulative maximum rainfall was recorded in the valley. The event lasted 4 days, with two rainfall peaks; the second one occurred at the same time as the maximum flood wave coming from the Upper Guil River (source: *MétéoFrance* and *EDF*, 2000).

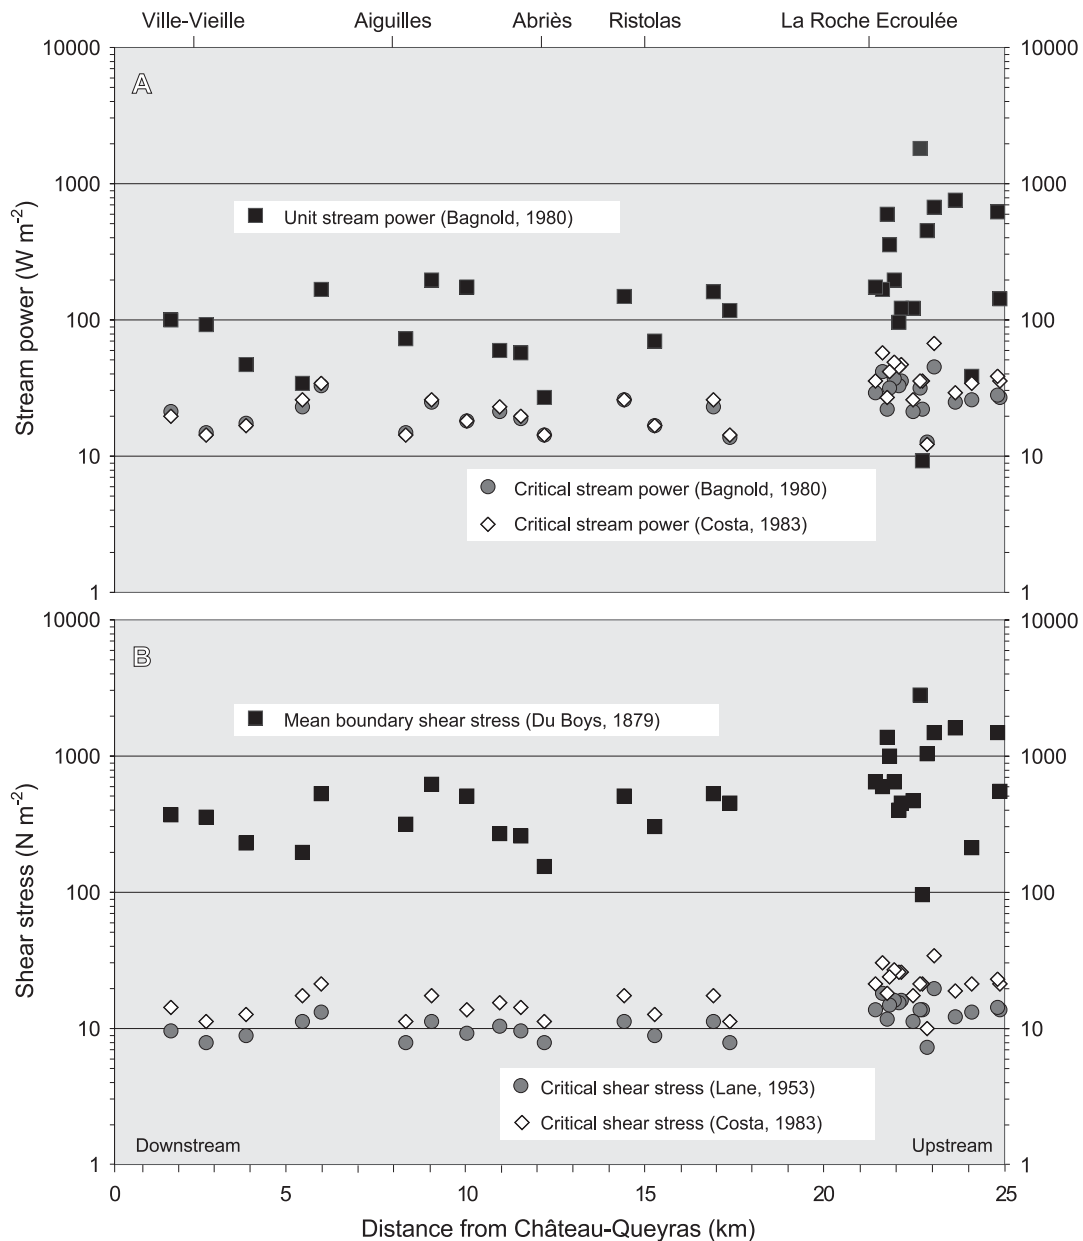
Fig. 5. Longitudinal distribution of stream power (A) and shear stress (B) in the Guil Valley, from its source down to Château-Queyras (June 2000). Important fluctuations in the hydraulic parameters are due to variations in longitudinal slopes. Note that values of critical stream power are everywhere lower than the values reached during the flood, a fact that explains the large volume of sediments mobilised and the high transport capacities.

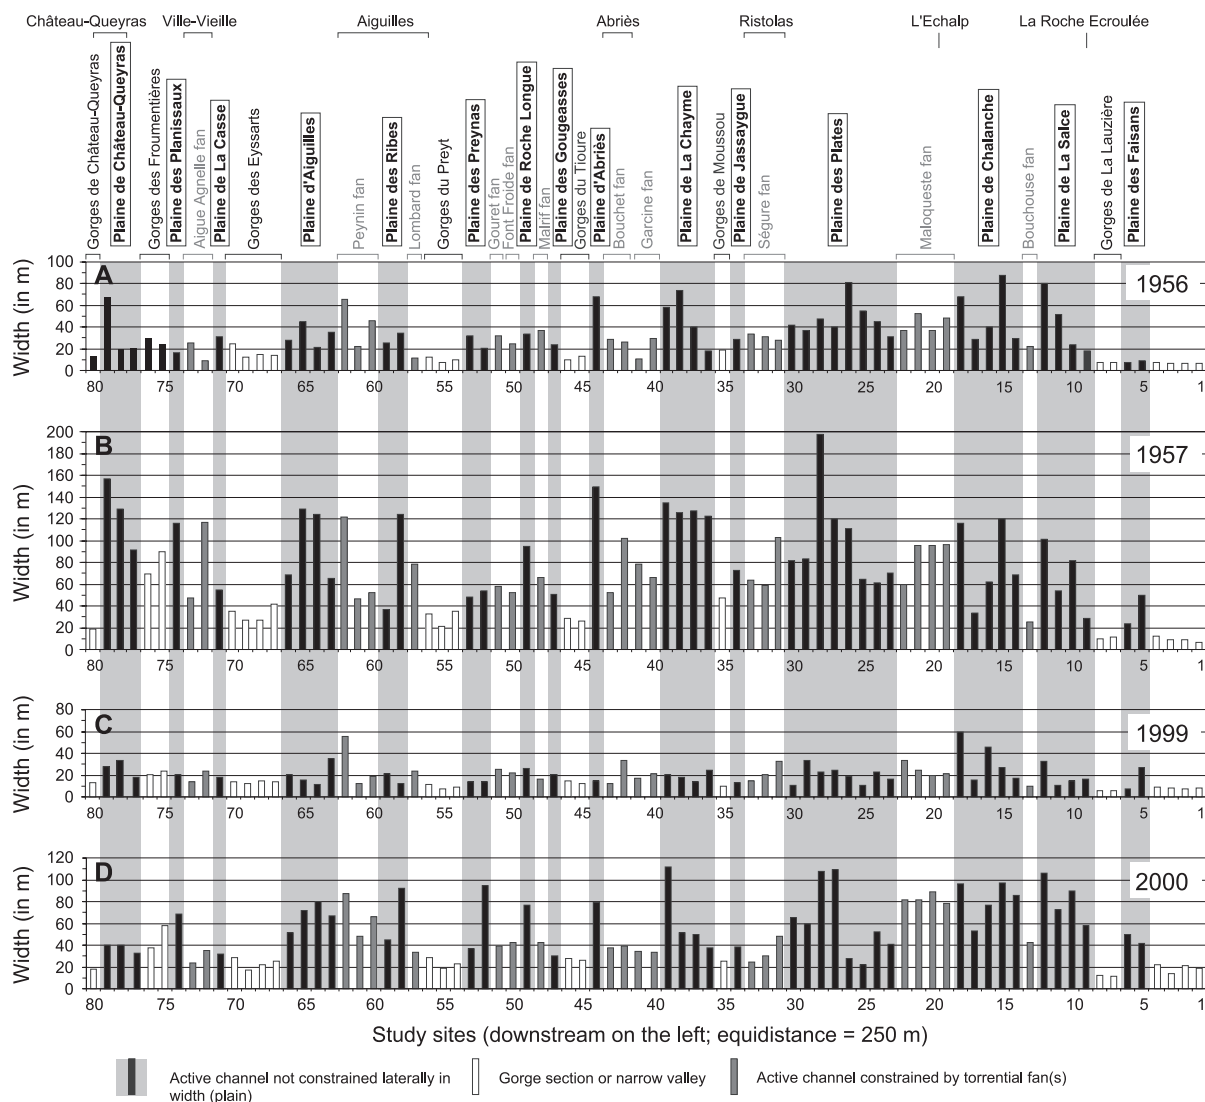
Fig. 6. Comparison of the active channel width of the Guil River before and after the June 1957 and June 2000 events (active channel width measured on IGN aerial photographs dated from 1956, 1957, 1999 and 2000). The amplitude of variations in active channel width depends on the section type (constrained or not by the presence of rocky outcrops and/or tributary fans). Upstream of La Roche Ecroulée (site 9), the impacts of both events are comparable, and the June 2000 event might even be larger. Downstream, the active channel width in 2000 was only about 40% of the 1957 channel width; yet locally (upstream of short gorge sections), the width was similar during both events.

One major impact of the flood was the enlargement of the active channel and the generalised bank erosion observed regardless of the section considered (Arnaud-Fassetta and Fort, 2004) (Fig. 6). In the wider areas, river banks collapsed and retreated, thus reinjecting a large volume of sediment into the active channel. Very locally, the “1957 flood terraces” (Tricart, 1974) were eroded as well. In the narrower sections, bank undercutting triggered many landslides, to the detriment of colluvial, morainic or weathered bedrock slopes (Fig. 7A). Artificial channel segments were also affected, with deterioration or partial destruction of dikes, gabions, concrete or blocky-armoured walls. For instance, the gabions and earthy dike protecting the camping ground of Le Chardonnet (Ristolas) were seriously undermined, and directly threatened the safety of campers (Koulinski, 2001). Also, most of the wooden footbridges used for hiking or cross-country skiing were washed away.

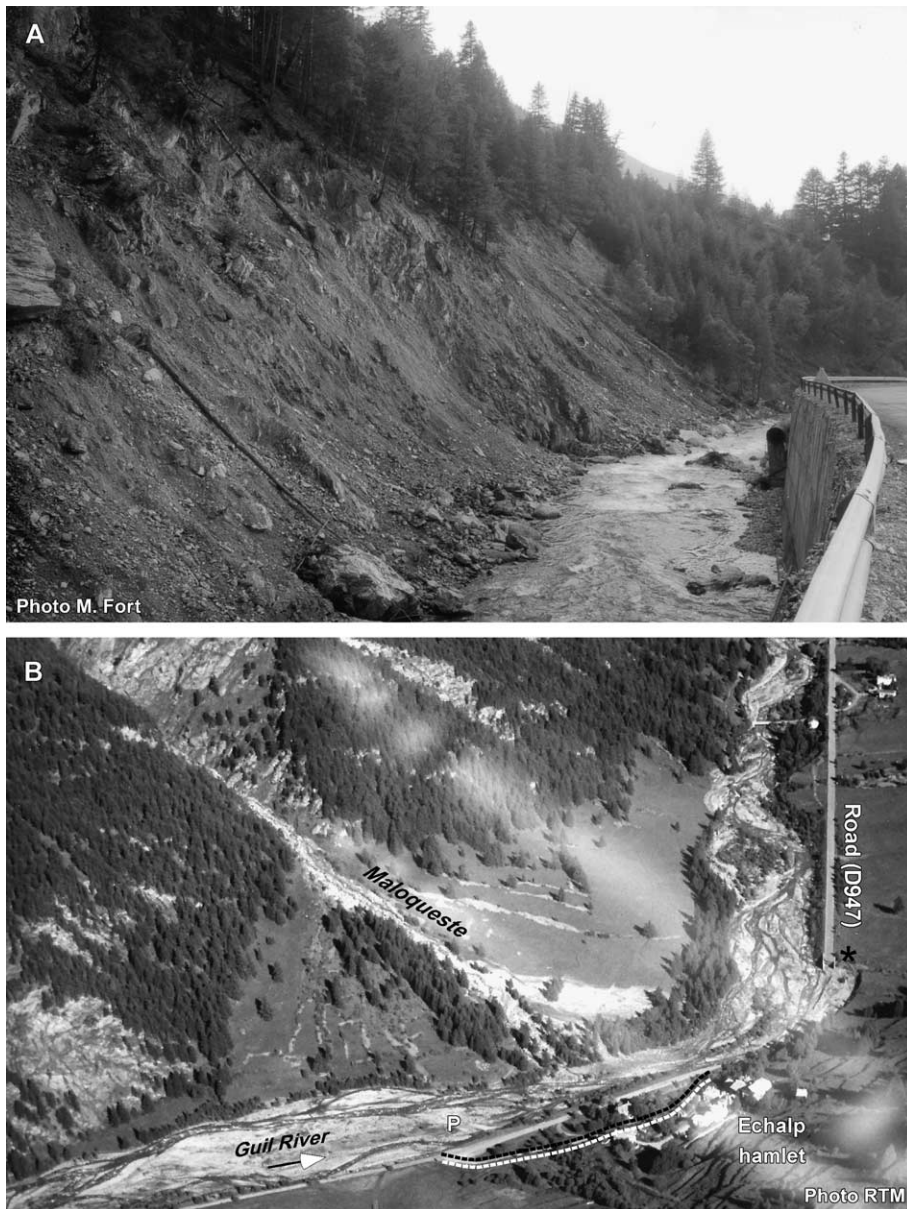
Fig. 7. (A) In the Preyt gorges, upstream of Aiguilles, the Guil channel is narrowed by the concrete wall and road embankment (right bank). Adjustments to fluctuations of discharge can only be accommodated on the left bank (landslides affecting the weathered slaty bedrock). Additionally, the concrete wall deflects the flow onto the opposite (left) bank with minimum loss of energy, reinforcing the destabilisation of the bank. (B) Aerial view of the confluence between the Guil River and the Maloqueste Torrent after the 2000 flood. Sediment and water transported by the Maloqueste Torrent deflected the Guil River onto its right bank. In addition, the Guil River enlarged its active channel to the detriment of the flood plain (change of a single-thread channel to braided channels). Both processes produced combined effects, with destruction along the right bank [parking area washed away (P), a 300-m-long stretch of the D947 road eroded (*), re-opening, right in front of the Echalp houses, of a former channel closed by the road embankment (double dashed line)] (RTM photograph).

upon the Guil floodplain, then deflecting the Guil onto its right bank, thus causing the destruction of a 300-m-long stretch of the road at the Echalp hamlet (Fig. 7B).

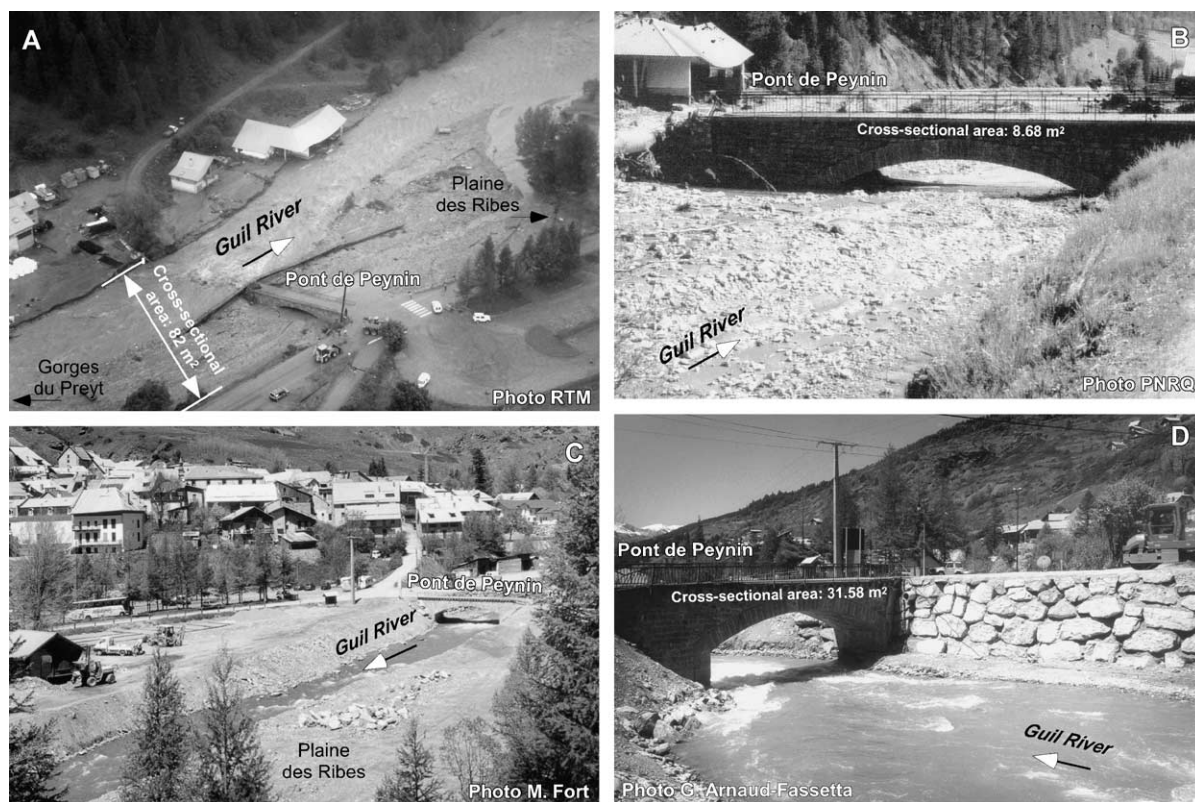
Fig. 9. The Peynin bridge at Aiguilles, during and after the 2000 June flood. (A) June 13th. Oblique aerial view (RTM) showing the Peynin bridge nearly buried by sediment and the new channel opened by the Guil River on its left bank. The cross-sectional area was 82 m². (B) June 14. Detail of the Peynin bridge, blocked by sediment (PNRQ). The cross-sectional area is reduced to 8.68 m². (C) July 2000. The Guil channel has been dug out, and the gravels removed have been piled on both banks as levees to re-establish one single channel flowing under the Peynin bridge. (D) May 2002. The upstream-progressing erosion subsequent to the dredging of the Guil riverbed has undermined the base of the bridge piles. Concrete stone armouring has been built in order to protect the right bank and the hospital downstream, whereas the left bank has been left unmanaged.

One generalised action (along both natural and urbanised reaches) was the narrowing of channel cross-sectional area by artificial levees, built with loose gravels taken up directly from the river channel (Fig. 9C). These stone dikes, stretching parallel to the low water channel, were meant to restrict the braiding river course within one channel as had been the case before the flood, and to force the river to incise its alluvial floor, thus indirectly reducing the frequency of over-bank floods. However, we speculate that this approach is illusory. First, bed armouring prevents channel incision during annual floods, so that the channel capacity remains insufficient for a 10- to 30-year flood event. Strong riverbed degradation (armour removal) increases the critical height of the levees for planar/slab failure. Second, during extreme events, these artificial levees offer little resistance to erosion because the channel competence during flood is greater than the resistance offered by the grain-size of the material constituting the artificial levees. In these conditions, the channel tends to widen and to be infilled, causing a higher flood risk in the flood plain (Fig. 15A).

Other measures adopted have included rebuilding bridges, at the same places and sometimes of the same size as before the flood. Although, following its destruction, the bridge connecting the road to the Peynin cone, downstream of Aiguilles, was rebuilt with a wider roadbed (30 m instead of 16 m), and so able to absorb the effects of higher river discharges, the same rather small cross-sectional area was retained in the case of the intact Peynin bridge. In fact, because of the cost of such a structure, it was decided to wait until another major flood destroys the bridge, so that a new, larger bridge will then be constructed, and the left bank protected (handicraft zone). So far, the left bank has been left unmanaged as the lesser evil, for the flooding of the handicraft zone is considered less of a disaster than the flooding of the hospital (concrete rock-armouring rebuilt on the right bank; Fig. 9D).

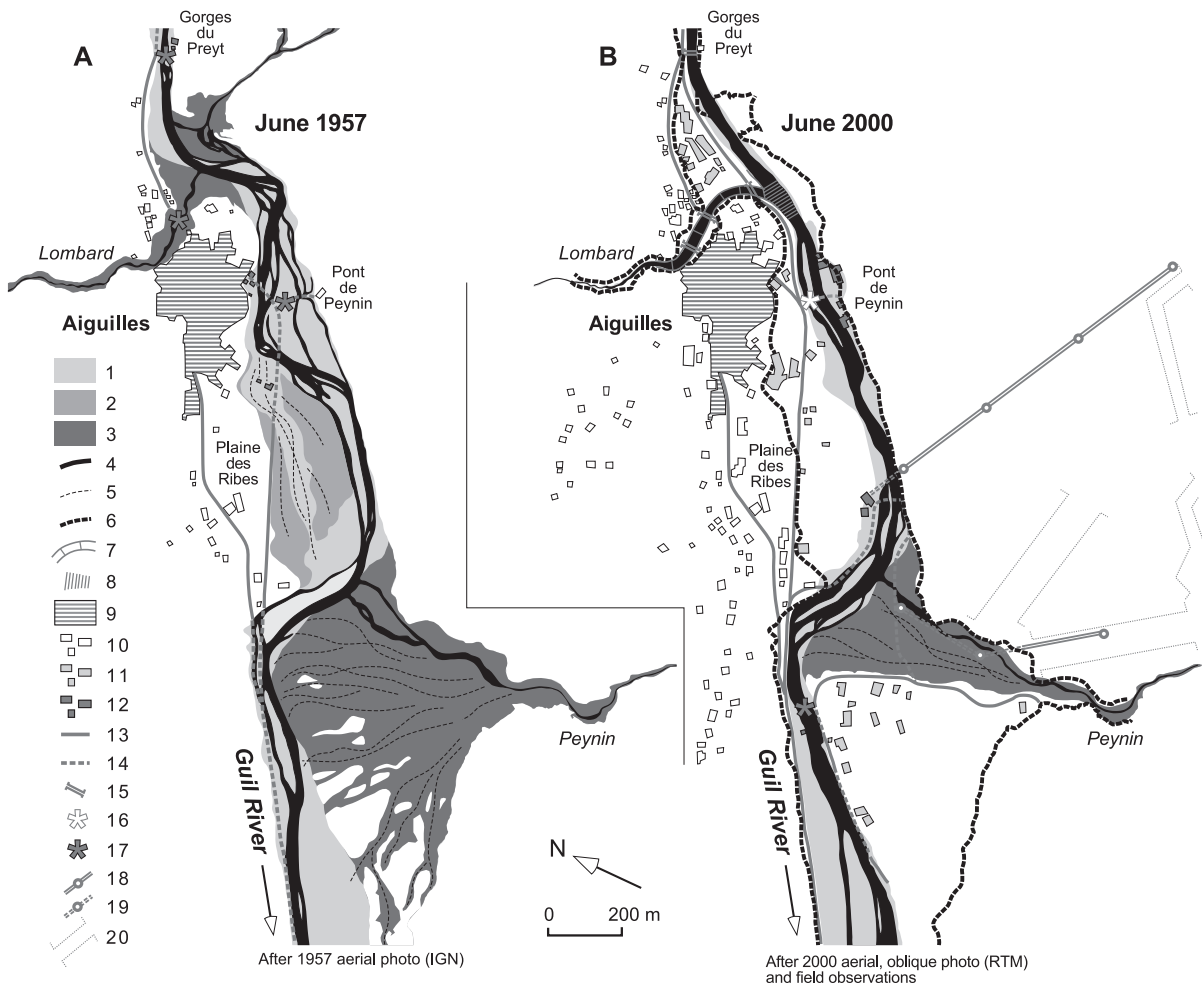
Fig. 10. Comparative maps showing flood impacts and land-use changes that took place in the Plaine des Ribes (Aiguilles village) between 1957 and 2000. Obviously, the vulnerability of this village has increased, due to the many buildings and activities sited in the former 1957 active channel of the Guil River and on the Peynin fan. 1=1957 active channel; 2=floodplain; 3=zone of aggradation (torrential fan); 4=main channel; 5=secondary channels; 6=1957 flood plain extent; 7=flood control structure: concrete embankment and weirs; 8=channel degradation control structure: concrete bed armouring; 9=village; 10=building away from the 1957 flood plain; 11=building sited on the 1957 flood plain, not flooded in 2000; 12=damaged building; 13=road; 14=damaged or destroyed road; 15=bridge; 16=aggraded bridge; 17=damaged or destroyed bridge; 18=ski pylon; 19=damaged or destroyed ski pylon; 20=ski run.

spread over the left bank, in the handicraft zone, thus reoccupying their former (pre-1957) channel course (Fig. 10). The two buildings of the carpenter's

very efficient structure has been undermined and is rapidly deteriorating (release of stones, collapsing slabs), with a >3-m-deep plunge pool accelerating the process. Ultimately, this process constitutes a threat to the Lombard artificial channel that protects the eastern part of Aiguilles village (Fig. 10B). A similar, though less critical situation is also observed at Ristolas.

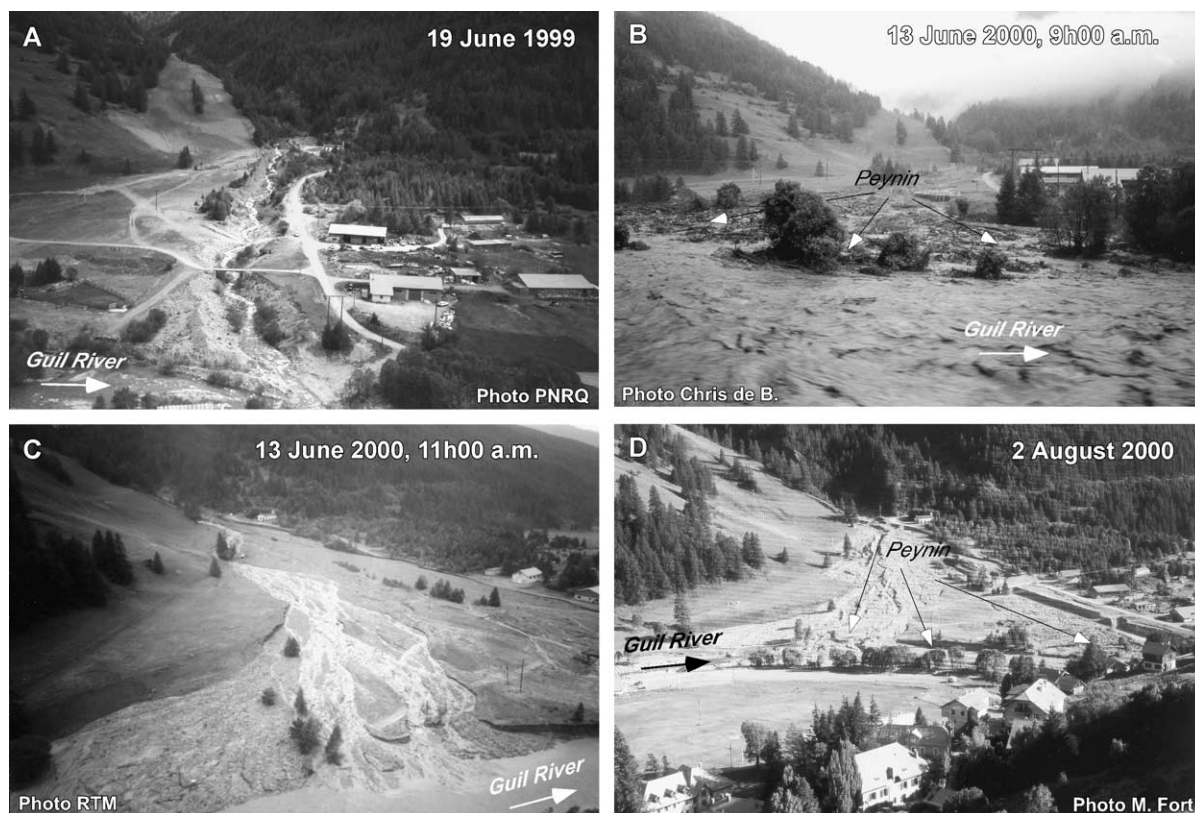
Fig. 11. Sequential series of photographs showing changes that occurred on the Peynin fan before (A), during (B), a few hours after (C) and a few weeks after (D) the overflowing of the Peynin fan. Before the 2000 flood, the fan was partly occupied by a handicraft zone (left bank) and by ski runs and installations (right bank). On the morning of June 13, the right bank was breached. The transport capacity of the Peynin, reinforced by its traverse through steep gorges upstream, explains the amount of debris suddenly deposited on the fan. A few weeks later, a new straight channel had been artificially dug out, and the right bank has since been re-shaped by bulldozing to restore the ski runs.

Another management intervention taken at Aiguilles only a few weeks after the flood was the digging of a new, straight, artificial channel for the Peynin stream, aligned at right-angles to the Guil River (Fig. 11D). Indeed, the handicraft buildings on the left bank had to be protected to the detriment of the right bank (ski runs). However, any further major flood is likely to see the re-establishment of the Peynin's course, which will continue to deflect the flow of the Guil onto the opposite (right) bank, thus posing a further threat to the already-damaged road embankment. In fact, a new scheme is under study, designed to deviate the entire Peynin course onto its left bank, in such a way that its confluence would join the Guil channel at a more acute angle (similar to the Ségure confluence), in order to avoid the damming effects of such tributary convergence (Kouliniski, 2000). However, the decision has not yet been made to modify the Peynin course because of local interests and conflicts.

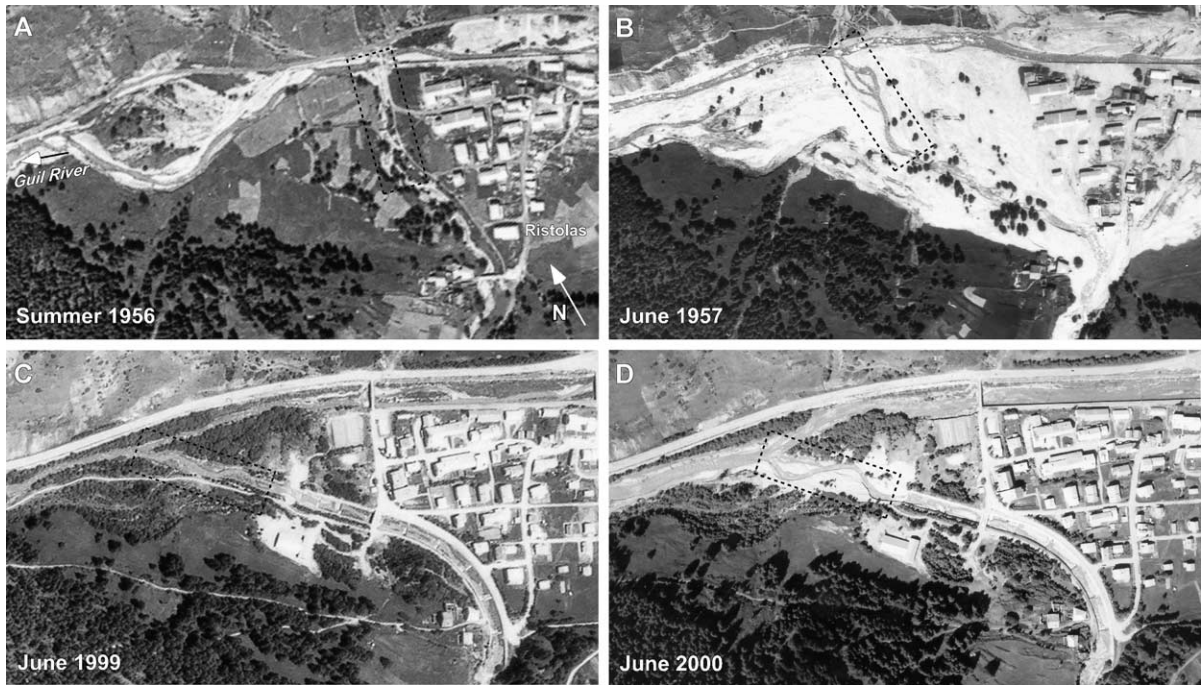
Fig. 13. Sequential series of photographs showing changes that occurred at Ristolas and on the Ségure fan, at the confluence with the Guil River. (A) Ristolas village is sited on the right bank of the fan. During summer 1956, the Ségure channel was narrow, partly colonised by riparian vegetation. (B) The 1957 flood extended across the entire fan. The village streets were covered with sediment to a depth locally exceeding 6 m. Agricultural land was devastated. (C) Flood control structures were built after 1957, so that the Ségure joined the Guil River at a very acute angle. In 1999, the Ségure was well constrained by the artificial channel (concrete-stony walls) along which weirs can be seen. (D) June 2000: after the flood, the only changes consist of an accentuation of the meandering channel trace and incipient braiding of the Ségure close to its confluence with the Guil. The post-1957 anthropogenic channel has efficiently protected the village, though a few weirs have been damaged.

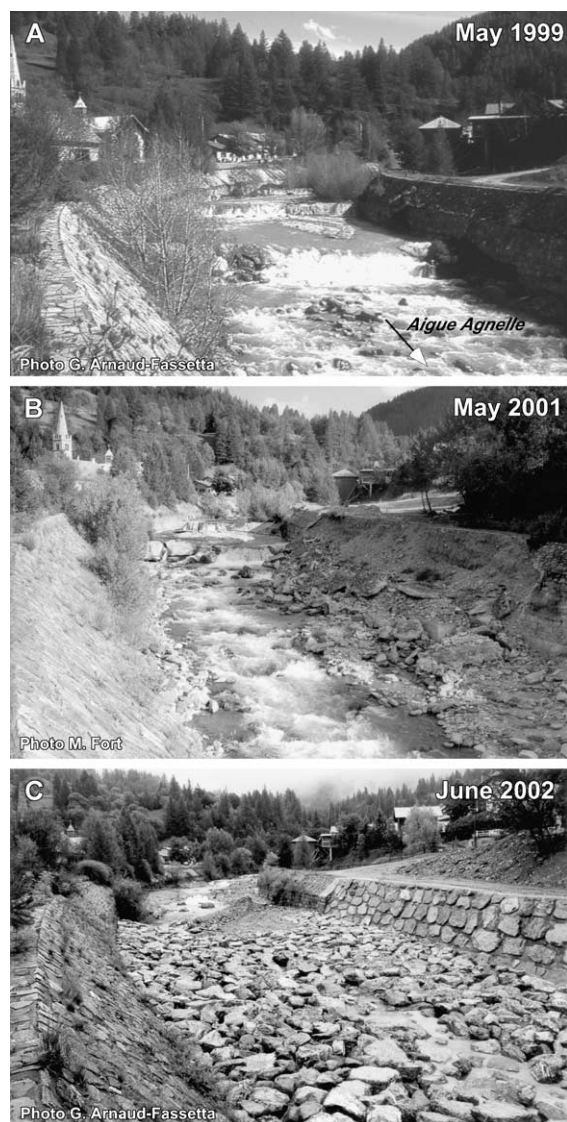
Fig. 14. (A) Hydraulic works (weirs, concrete bank armoring) along the Aigue Agnelle course on the Ville-Vieille fan. (B) Note the important damage to structures following the 2000 flood, due to channel degradation and widening on the convex (left) bank. (C) During summer 2002, the channel floor was repaired and a bed armoring consisting of concrete blocks was built.

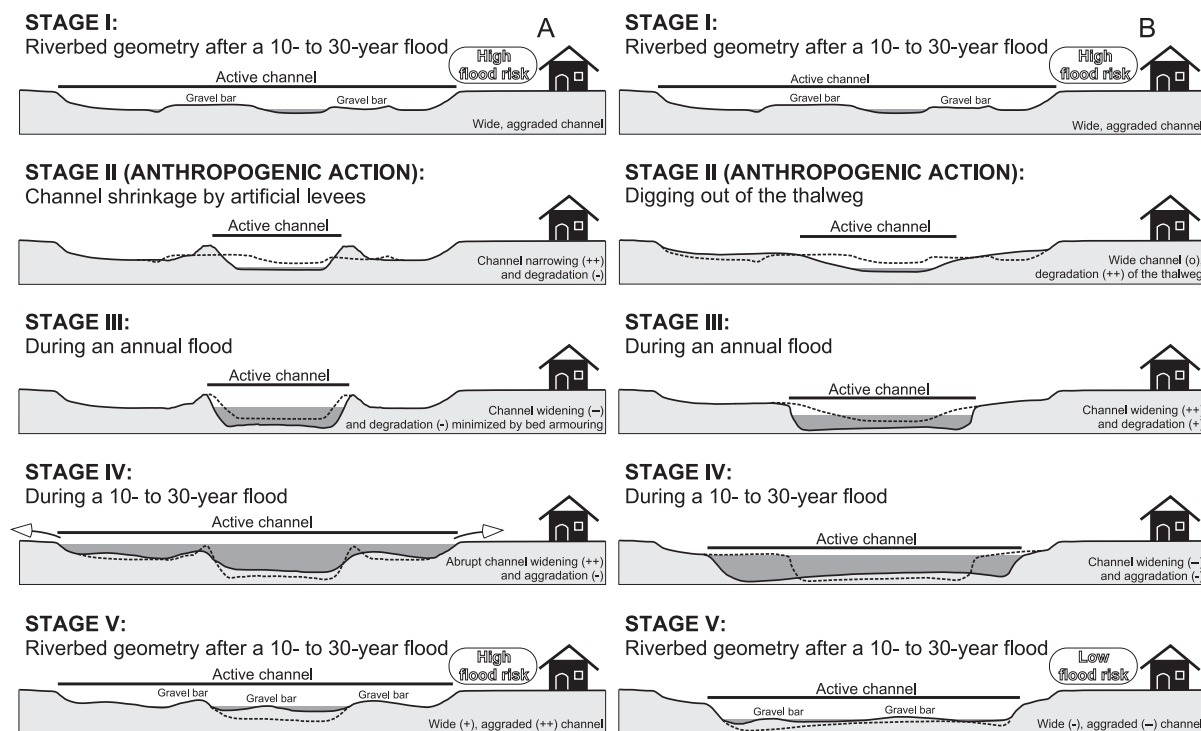
Fig. 15. Types of control measures on the active channel, involving (A) artificial levees and (B) excavation of the channel, with distinctive, speculative effects on evolution of the channel geometry. Note that cross-sectional area is the same in both case.
