The Kagbeni flood event (August 13, 2023), Mustang District (Nepal): Triggers, sediment cascades, aggravating infrastructures and disaster risk management

Monique Fort ^{a*}, Narayan Gurung ^b, Perrine Yvrard ^a, Rainer Bell ^c, Katy Burrows ^d, Bhagawat Rimal ^e, Gilles Arnaud-Fassetta ^a

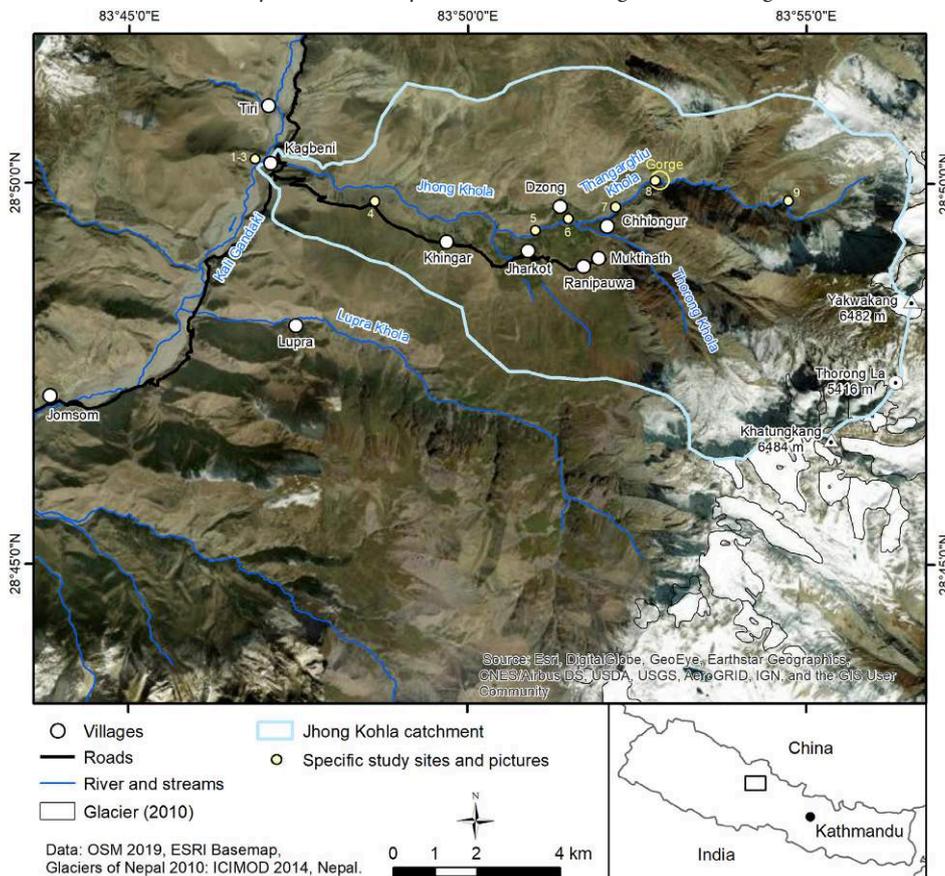
Fig. 2 – Jhong Khola catchment. The Kali Gandaki flows southwards.

The small circles and numbers refer to study sites and photos mentioned in the other figures. (1-3): fig. 3, 13B, 13C, 14-18; (4): fig. 9; (5): fig. 11; (6): fig. 12; (7): fig. 10; (8): fig. 7; (9): location of landslide sites, fig. 6

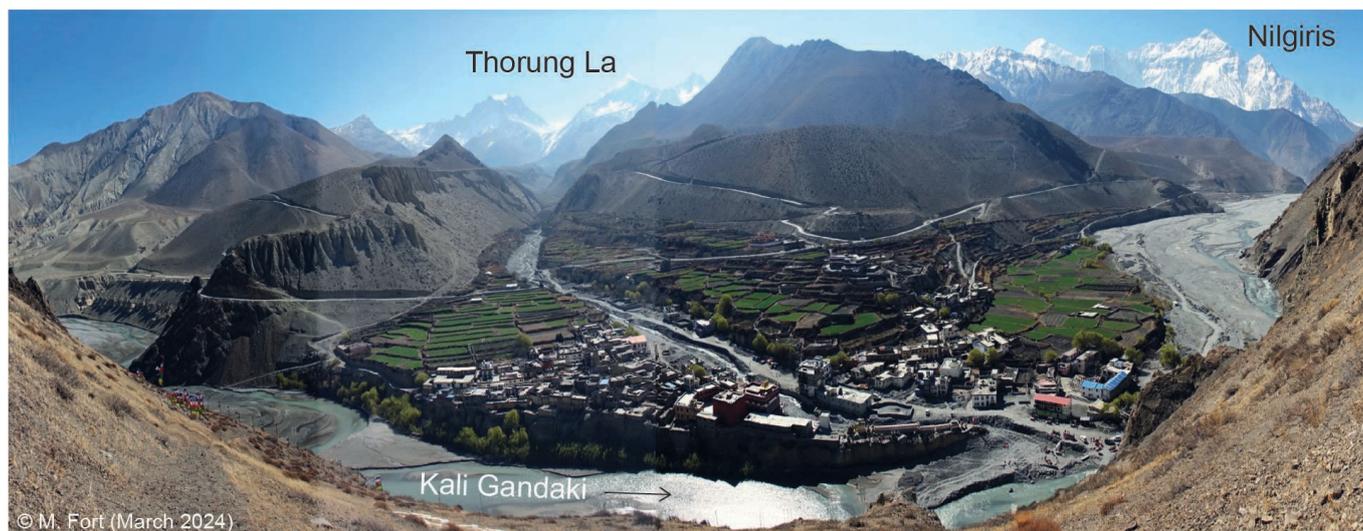
Fig. 3 – Kagbeni and the Jhong Khola catchment viewed from the opposite, right bank of the Kali Gandaki seven months after the flood.

The old Kagbeni village (center left of the picture) is perched on the right bank, with the Buddhist monastery (tallest buildings) close to the junction. Downstream from the Mustang Road and along the village, the natural width of the Jhong Khola riverbed has been reduced by artificial channelization. The August 13, 2023, hyper-concentrated flood event has widely affected both riverbanks of the Jhong Khola, and more specifically the left bank (on the right). A large part of the fan built by the flood debris is still present, controlling the flow of the Kali Gandaki. In the back and bounded by two peaks (elevation close to 6500 m), the Thorung Pass (5416 m) gives access to the adjacent Manang/Marsyangdi valley to the East, whereas on the south (right), the Nilgiris range (> 7000 m) is hiding the Annapurna Range (> 8000 m) located to the South (photo: M. Fort, March 12, 2024).

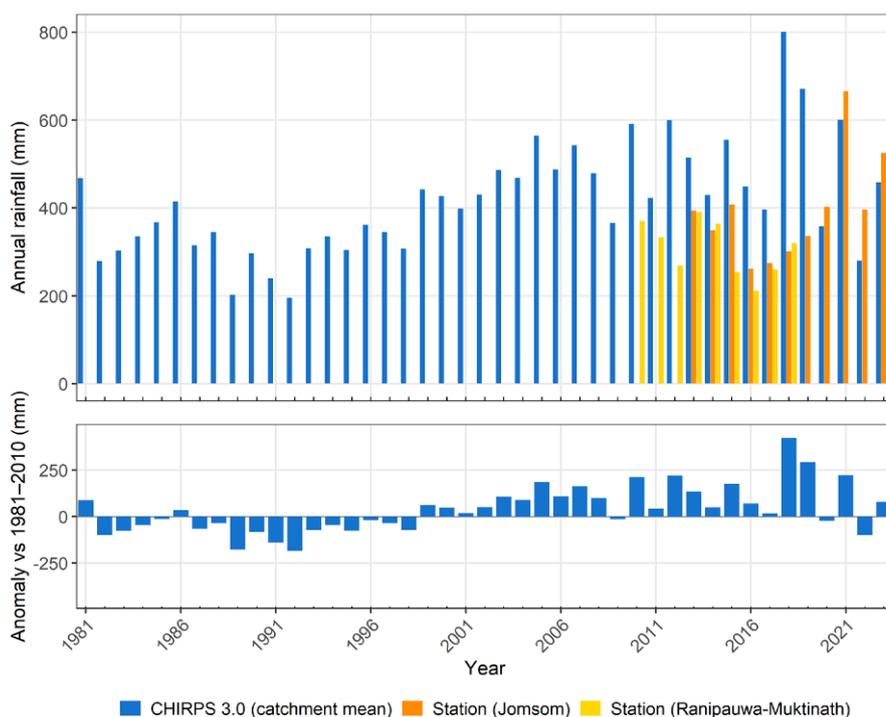
Fig. 4 – Annual rainfall data of the studied area.

Annual rainfall in Jhong Khola catchment (1981-2023, CHIRPS 3.0 data), Jomsom station (2013-2023) and Ranipauwa-Muktinath station (2010-2018). Anomaly of annual rainfall 1981-2023 compared to the average of 1981-2020 (CHIRPS 3.0 data). Source: CHIRPS 3.0: <https://www.chc.ucsb.edu/data/chirps3>; station data: GoN (Nepal Government), Dpt of Hydrology and Meteorology, www.hydrology.gov.np.

Precipitation data are mostly provided by the Department of Hydrology and Meteorology (DHM) of the Nepal Government. In Mustang, Jomsom station (2850 m, 10.7 km south of Kagbeni; fig. 2) is the most reliable as it was established in July 1957. Another station was located in Ranipauwa-Muktinath (3609 m), but it was only operational for a few years (Environment Statistics of Nepal, 2024), and since 2018, it has not been repaired (fig. 4).

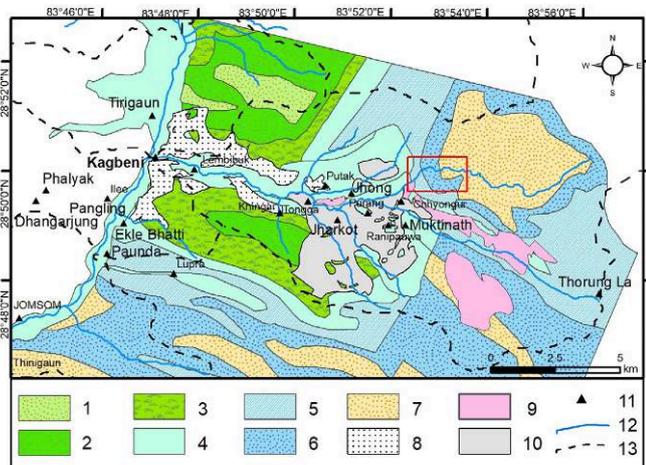
Fig. 5 – Geological map of the Jhong khola catchment.

1. Muding Unit: Black shale; 2. Kagbeni Unit: Greywacke, sandstone and conglomerate with volcanoclastic pebbles; 3. Chuck Unit: Sandstone and brown siltstone; 4. Lupra Formation: Black shale; 5. Bagung Formation: Bioclastic and micritic limestone; 6. Jomsom Formation: Oolitic and bioclastic limestone; 7. Thini Formation: Shale and limestone; 8. Late Quaternary and Holocene glacio-fluvial and fluvial gravels; 9. Late Quaternary and Holocene morainic material; 10. Recent and present slope instabilities; 11. Villages; 12. Hydrographic network; 13. Outlines of Jhong khola catchment and sub-catchments (adapted from Parsons et al., 2014, and completed by data from Fort, 1985).

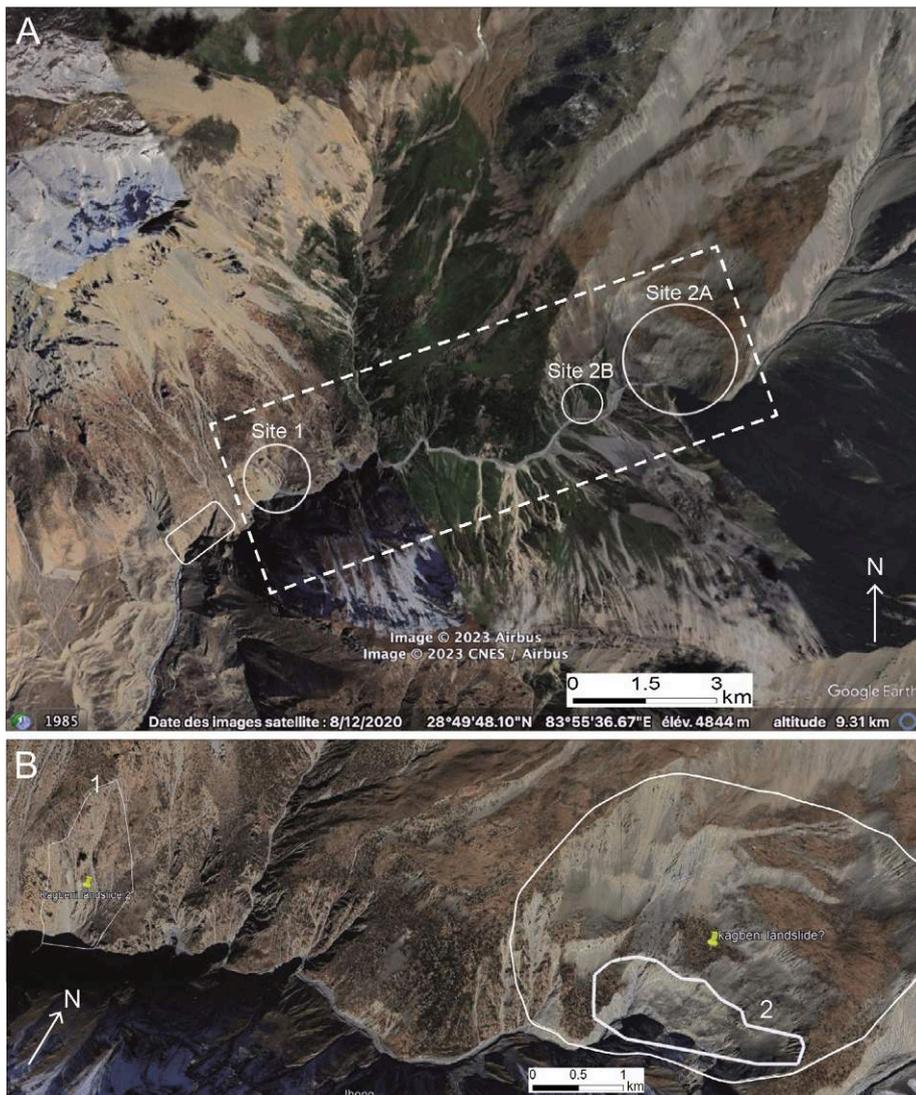
Fig. 6 – Elements for landslide development in the upper Jhong Khola catchment. A: satellite Image (2023 CNES Airbus) showing (i) the location of the gorges (rectangle) and (ii) the sites of potential landslides (circles); after detailed analysis, only Sites 1 and 2 were considered; B: detail of the Sentinel-1 Synthetic Aperture Radar showing the most likely site (2A) for the landslide dam (rotational slides in Thini formation). Location: fig. 2, site 9.

Sentinel-1 interferometric synthetic aperture radar (InSAR) satellite images were used to carry out coherence analysis over two slopes (Sites 1 & 2, fig. 6) identified as the potential source areas of landslides, located upstream of the Thangarghiu gorges (fig. 7; location study site 8, fig. 2). The landslides studied here failed too rapidly for the deformation to be measurable using differential InSAR techniques, but InSAR coherence analysis

Site 2A) which has failed. The interpretation of this consistently low coherence at site 2A as landslide activity makes sense as the optical image displays a multi rotational-slumped area developed in the shaly Thini Formation (Parsons et al., 2014); this reinforces the possibility of a landslide blocking the valley bottom already in Late July 2023, at < 2.5 km upstream from the Thangarghiu gorges.

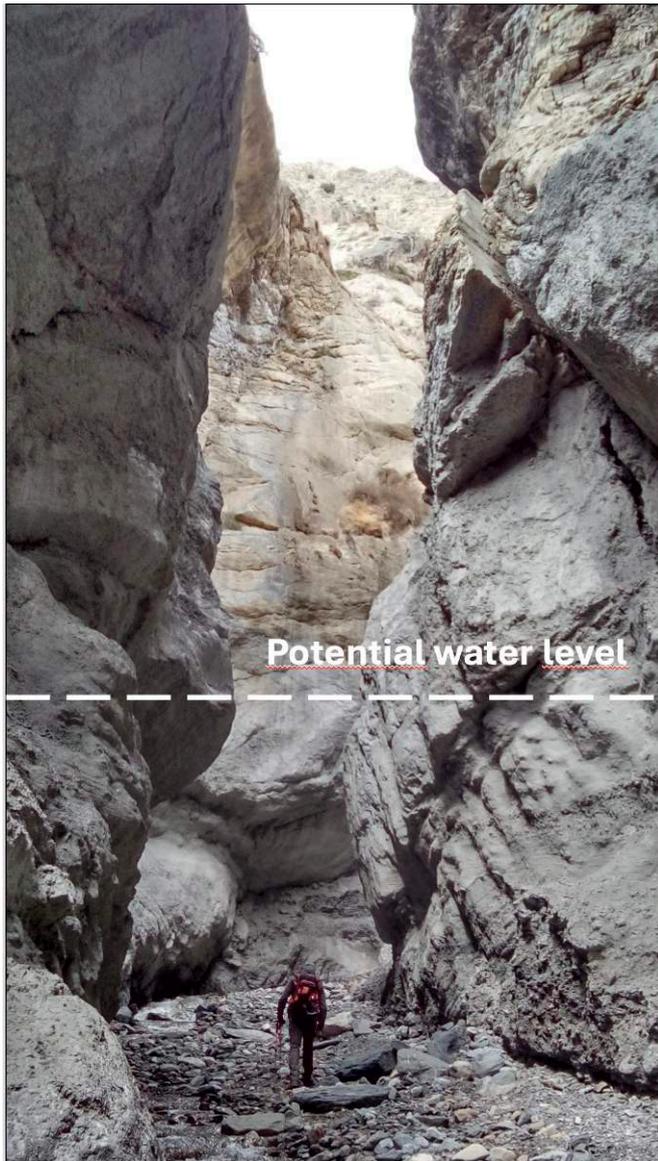
Fig. 7 – Thangarghiu gorge.

The width of the gorge varies from about 8 to 10 m, and the potential water level reached during the flood was at least +6 meters (photo: Rainer Bell, 2020). Location: fig. 2, site 8.

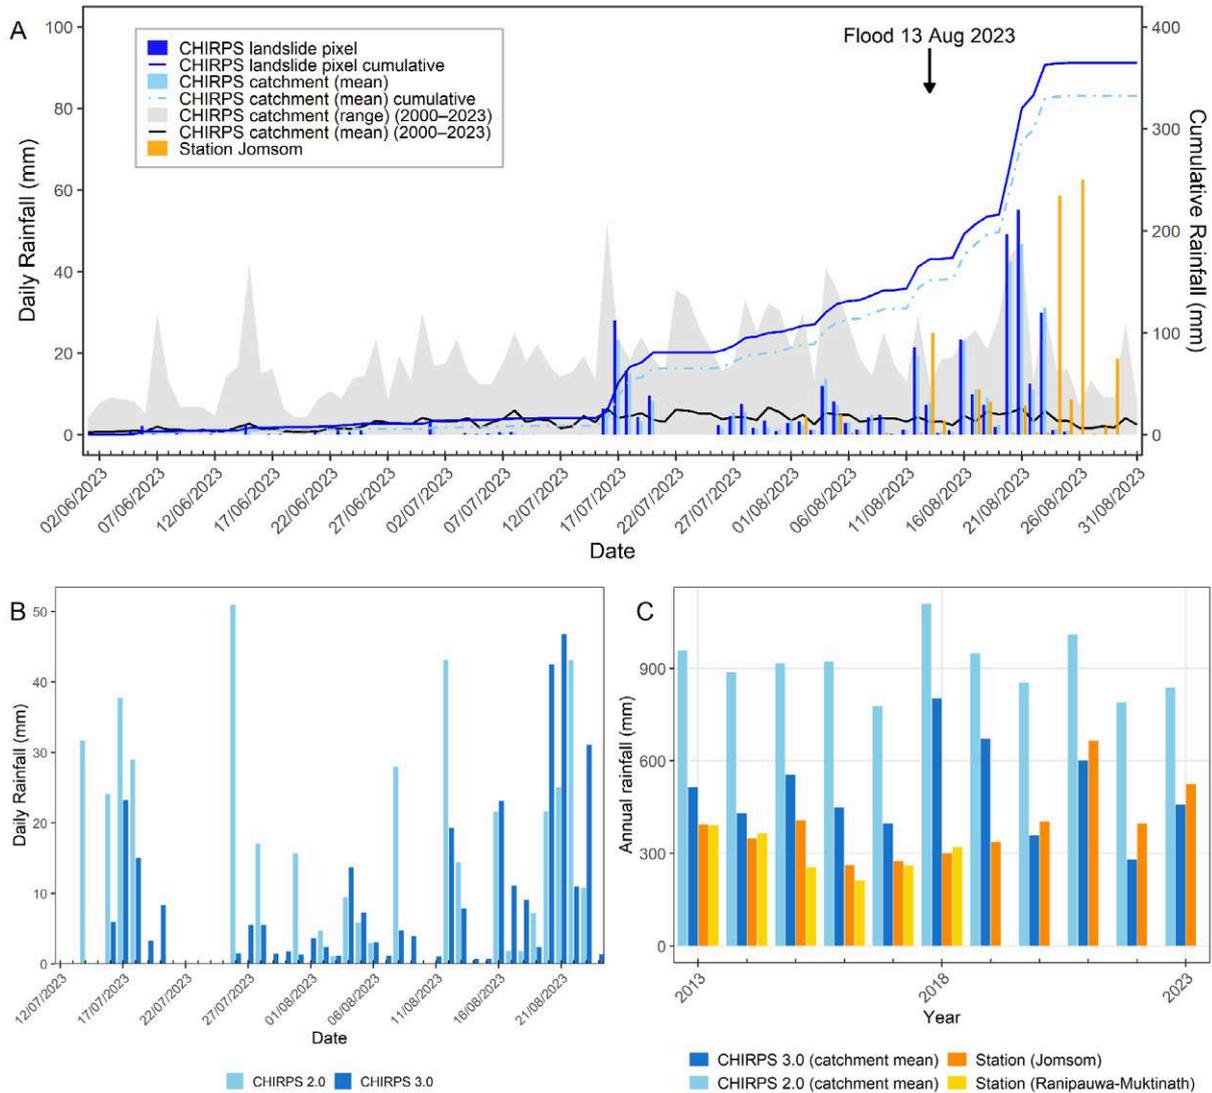
Fig. 8 – Daily rainfall of June-August 2023 based on CHIRPS 3.0 and 2.0 as well as August 2023 rainfall registered at Jomsom station. A: CHIRPS 3.0 daily and cumulative rainfall for the CHIRPS pixel including the landslide site as well as for the Jhong Khola catchment. In addition, mean daily rainfall and the range of daily rainfall is shown based on CHIRPS data. Daily rainfall for Jomsom station was only available for August 2023; B: comparison of CHIRPS 3.0 and 2.0 daily rainfall data (12/07-23/08/2023); C: comparison of annual rainfall data using CHIRPS 3.0 and 2.0 as well as station data

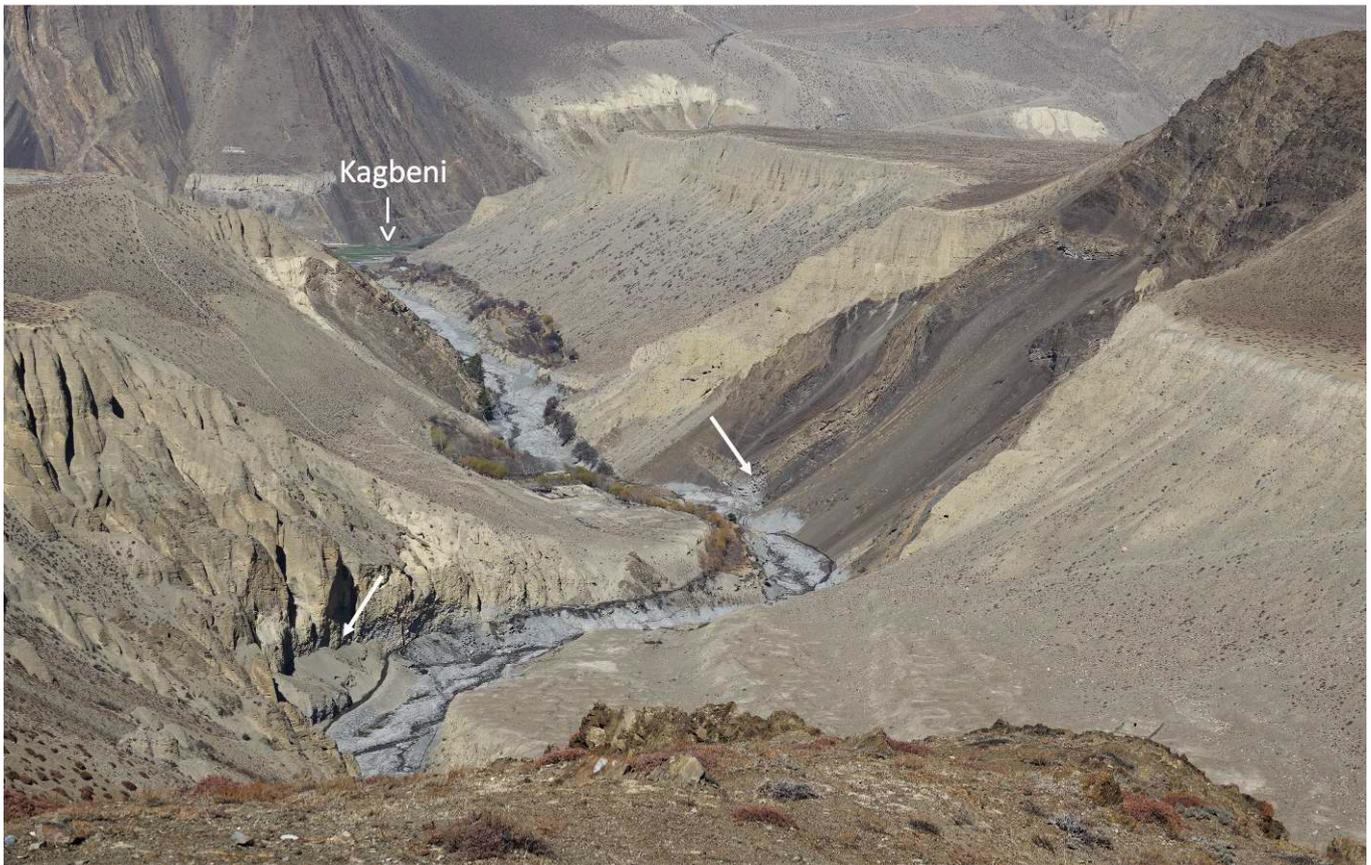
Fig. 9 – Cascading impacts of the flood downstream the Jhong khola.

From the highest terrace level (> 3100 m) located northwest of Khingar village, an overview of the Jhong Khola in its downstream section before the confluence with the Kali Gandaki (fig. 2, site 4). The river cuts through differentiated substrates: (i) bedrock (sandstones in the foreground, black shales in the middle ground, and glacio- and alluvial gravels in the background at Kagbeni), (ii) yellowish, slightly indurated Quaternary terrace and lacustrine deposits and (iii) slope debris. The light grey color of the valley floor and riverbed gives an idea of the variable height (3 to > 10 m) reached by the muddy flows of the flood in the meanders, splashing higher against vertical concave banks (as shown by white arrows) (photo: M. Fort, March 14, 2024).

meandering trajectory of the Jhong Khola was the cause of the variable height reached by the muddy, splashy waters, much higher (> 10 m) in the concave, rocky banks than in the convex banks (± 5 m).

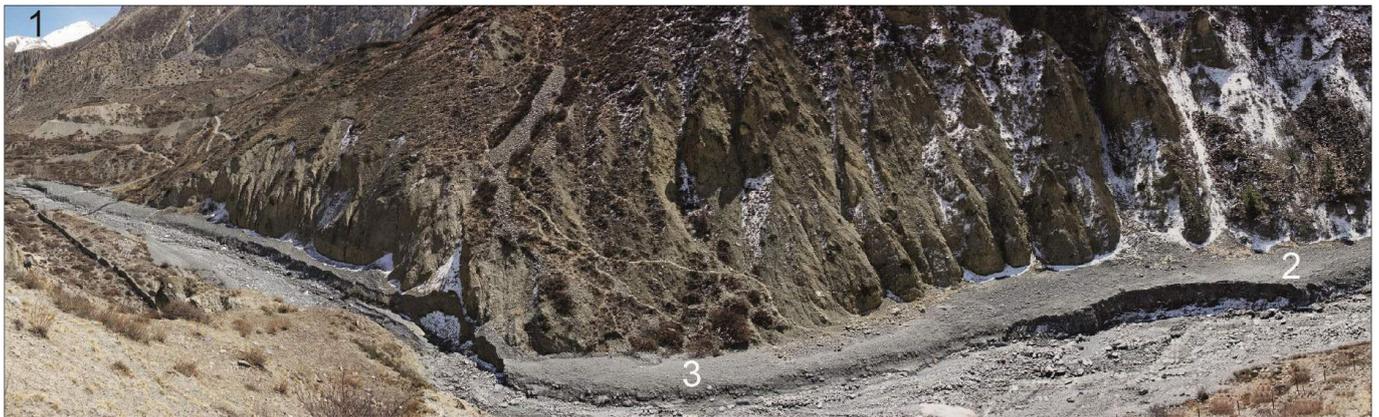
Fig. 10 – Propagation of the flood downstream of the Thangarghiu gorges (fig. 2, sites 7 to 8).

The gorges are on the left of the photo (1). Grey areas at the bottom of the valley reflect the increase in water discharge and correspond either to veneers on pre-existing terraces (2) or to new flood deposits (3) (fig. 2, sites 7 à 8). (photos: M. Fort, March 16, 2024).

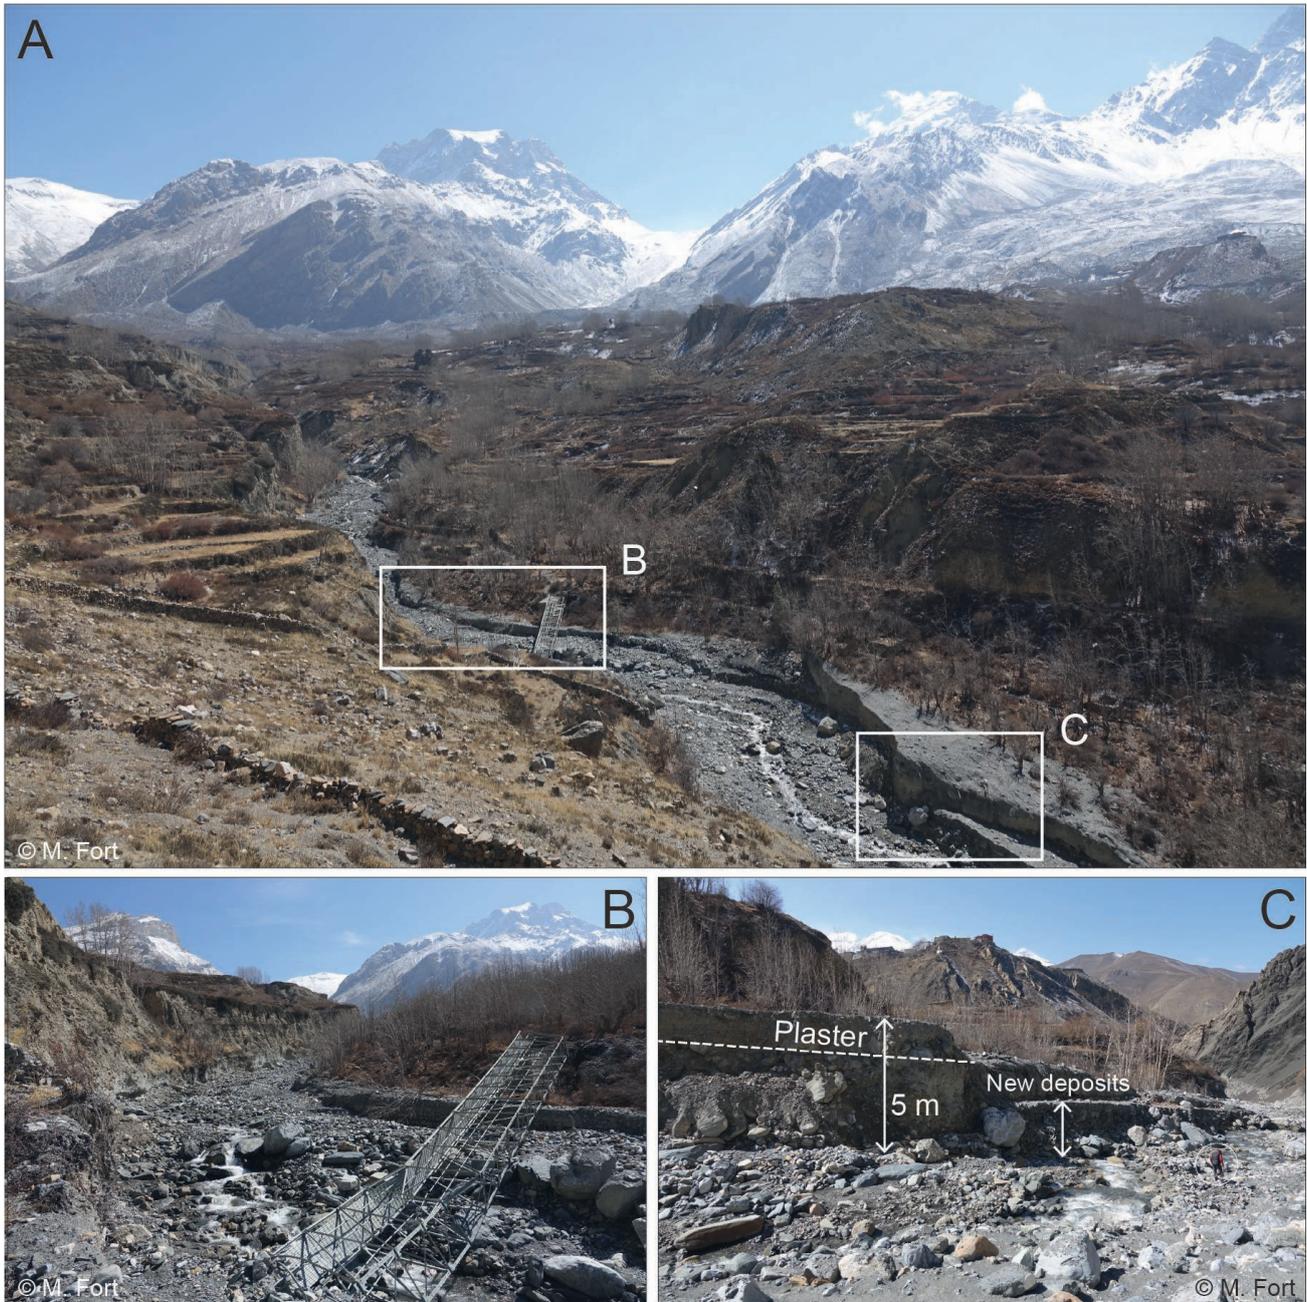
Fig. 11 – Impacts of the flood across the large earthflow affecting the left bank of the Jhong Khola. A: general view of the southern flank of the Jhong Khola affected by a large earthflow, with Thorung La (5300 m) in the background. The flood had several impacts on infrastructure and riverbed morphology; B: tilted bridge between Jharkot village (middle ground) and Dzong village (behind the picture); C: the minimum height of water reached during flooding can be identified by (i) a veneer of debris-flow facies overlying a pre-existing terrace, and by (ii) new deposits (fig. 2, site 5). (photos: M. Fort, March 17, 2024).

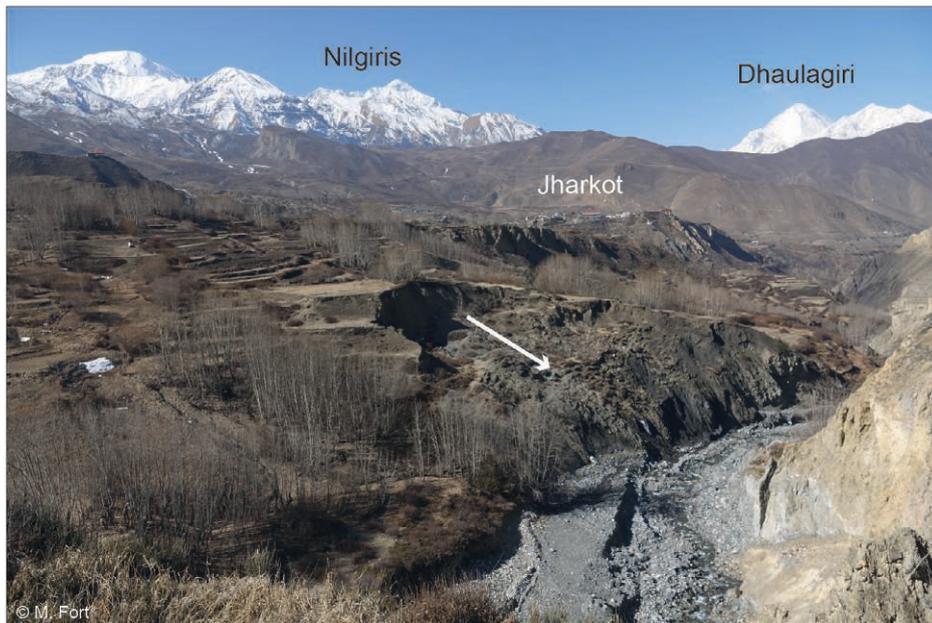
Fig. 12 – Landslide reactivation (Spiti shales bedrock) due to bank erosion by the flood.

This landslide (3300 m), located between the villages of Chhiongur (3650 m) and Jarkhot (3550 m) (fig. 2, site 6), developed in the black shale substrate of the Lupra Formation (Parsons et al., 2014) (photo: M. Fort, March 17, 2024).

At several sites, we observed landslide reactivation due to bank erosion, favoured by narrowing of the riverbed due to contrast in bedrock. Bank erosion was particularly evident along the left bank, along which the large landslide-earthflow complex of Khingar/Jharkot (Fort, 1985; Etzelstorfer, 2020; Goetz et al., 2020; Bell et al., 2021) provides additional fine sediments/mud to downstream flow hence increasing the density of the flow and making the flood even more destructive. Some sites clearly show this reactivation (fig. 12).

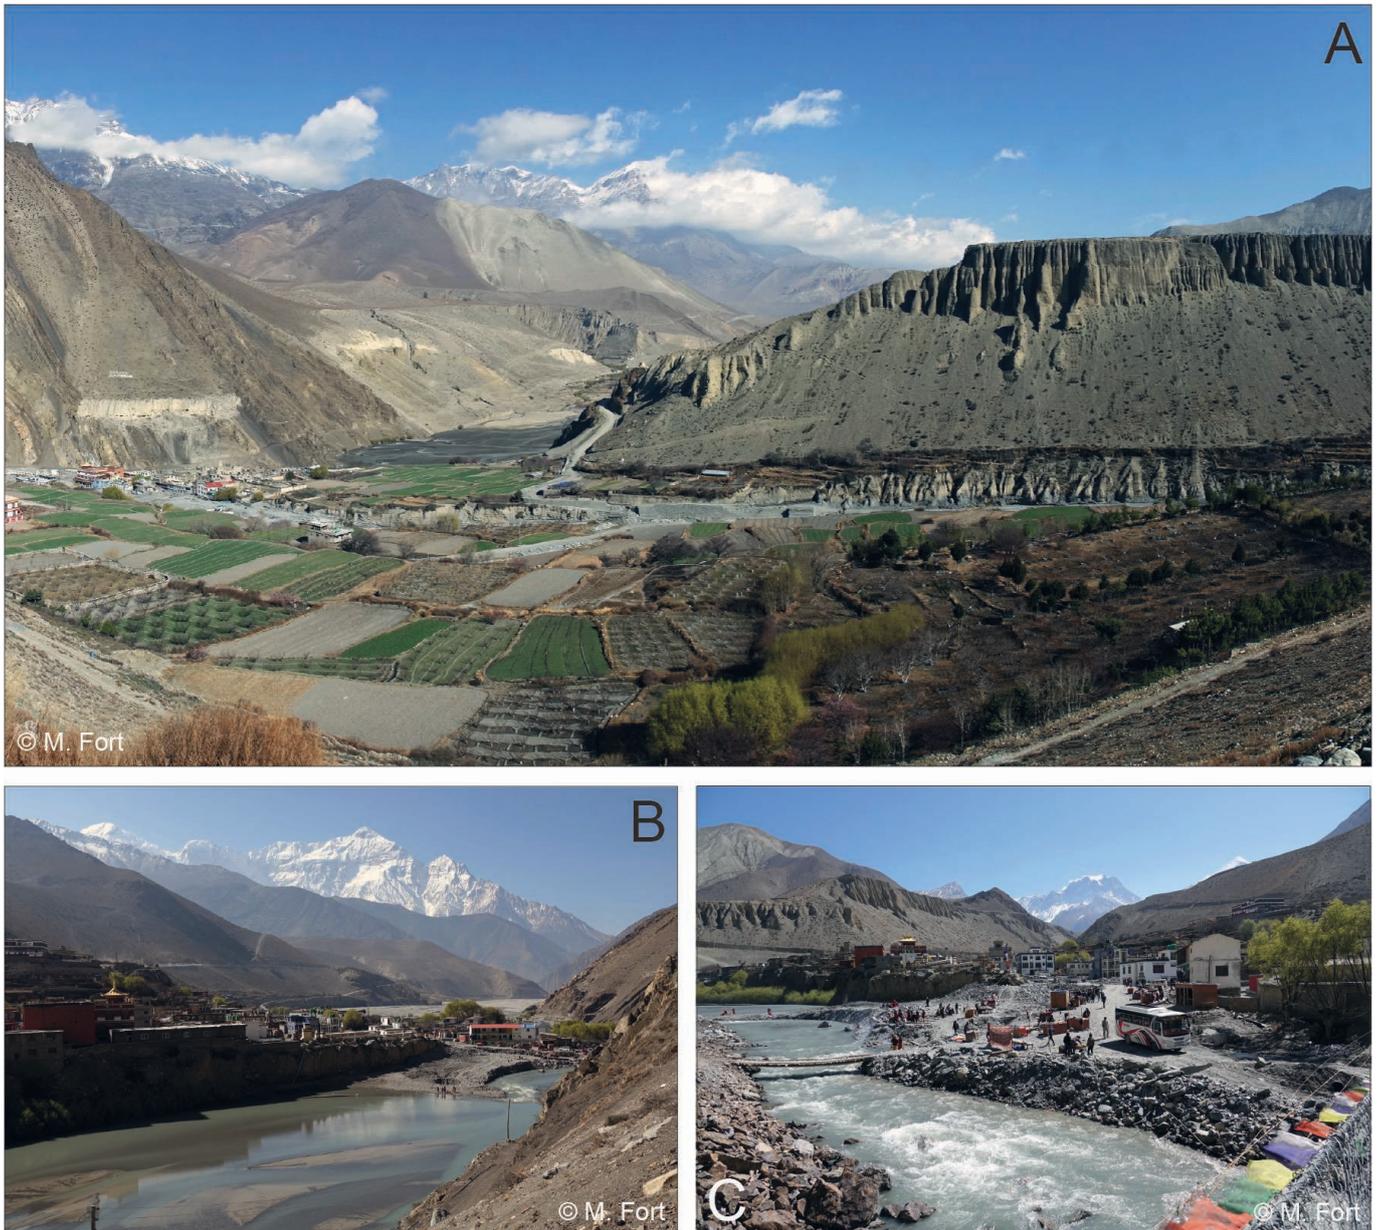
Fig. 13 – Kagbeni village and its confluence with the Kali Gandaki, view after the flood. A : general northward view (from a left bank terrace) of the village, with the motor road going up to upper Mustang, and the Jhong Khola (noticeable with its light grey color) crossing the village (fig. 2, site 3). The Kali Gandaki River flows between the village and its cultivated land (foreground) and the rocky hillslope cut into the Mesozoic Chukh Formation (background on the left); B: remnants of the flood fan of the Jhong Khola and the still flat inundated riverbed of the Kali Gandaki (active riverbed width: 70 m in the foreground, 7-8 m in the middle ground), with the Nilgiri North peak (7061 m) in the background (fig. 2, site 1); C: the junction fan deposited during the 2023 flood event is now partly eroded, as observed from the right bank of the Kali Gandaki towards East (fig. 2, site 2). (photos: M. Fort, March 12, 2024).

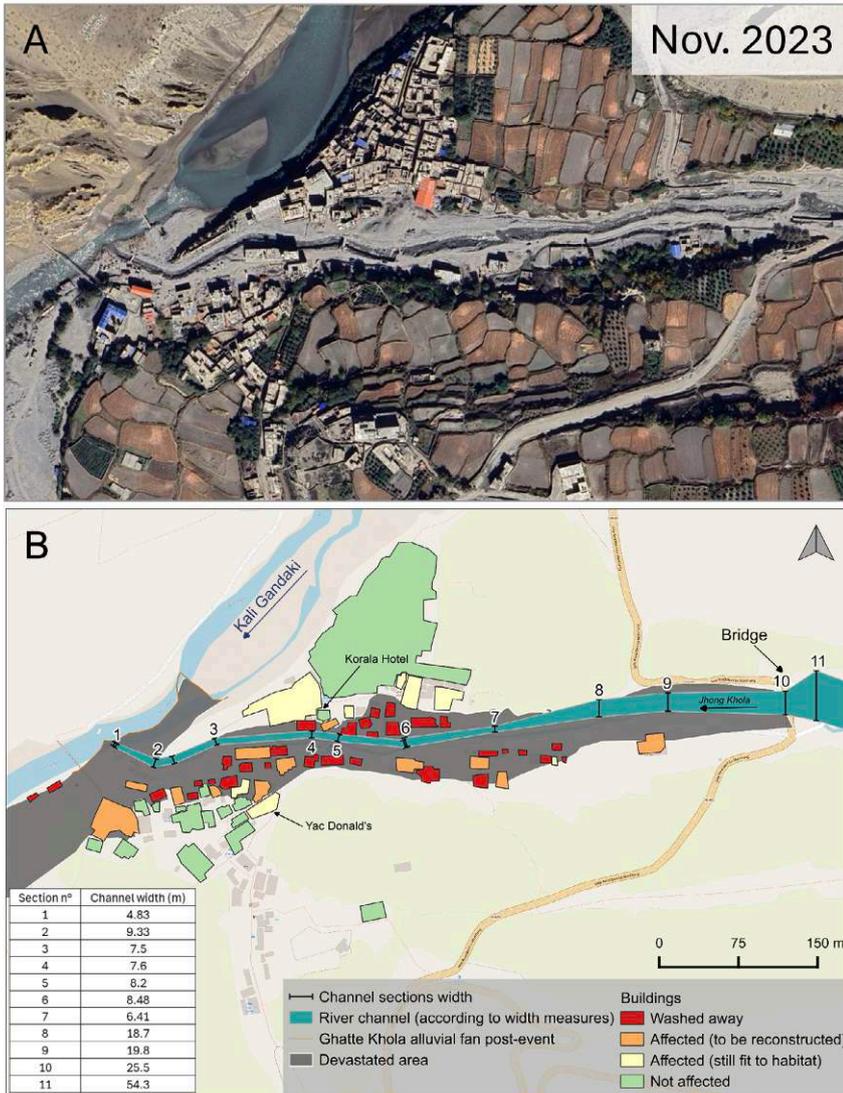
Fig. 14 – Impacts of the flood in the village of Kagbeni. A: Google Earth Image (November 2023) showing all the flooded areas (in grey); B: map showing the devastated areas by the flood and the different degree of damage on the buildings; the table (left) confirms the drastic reduction in the width of the Jhong Khola canal in the village, downstream of the upper Mustang Road bridge (data collected and map drawn by P. Yvrard, 2024).

The collapse of the bridge's concrete deck was an aggravating factor (Section 10, fig. 14B). The increased volume and density of the water caused the deck to detach from its pillars, and it was swept away by the muddy flood downstream. Its zigzagging trajectory, from one bank to the other, was very destructive and explains the loss of so many buildings and various shelters, as well as 6 smaller bridges, trees and gardens, on both banks of the village (fig. 16). Cattle and vehicles were also washed away. Most of the houses closest to the riverbanks were destroyed, after having partially protected other houses located behind them: the Grand Hotel, or the private home of the Shangri-La Hotel owner. Although impacted, these two houses were later repaired (see below). Another older, narrower, motor bridge linking the left bank to the Red House (fig. 16) then to the old village (Section 6, fig. 14B) was also washed away: its deck was dragged down to the level of the Buddhist monastery and amplified the destruction on both banks caused by the deck of the major bridge.

Changes in width of sections of the Jhong Khola (table of fig. 14B) amplified the damage in the village. Before the 1970's, the left bank of the river and lower terraces were only cultivated lands or meadows, while the traditional village was built on the right bank terrace ≈ 10 m higher than the present riverbed around the Buddhist monastery (5

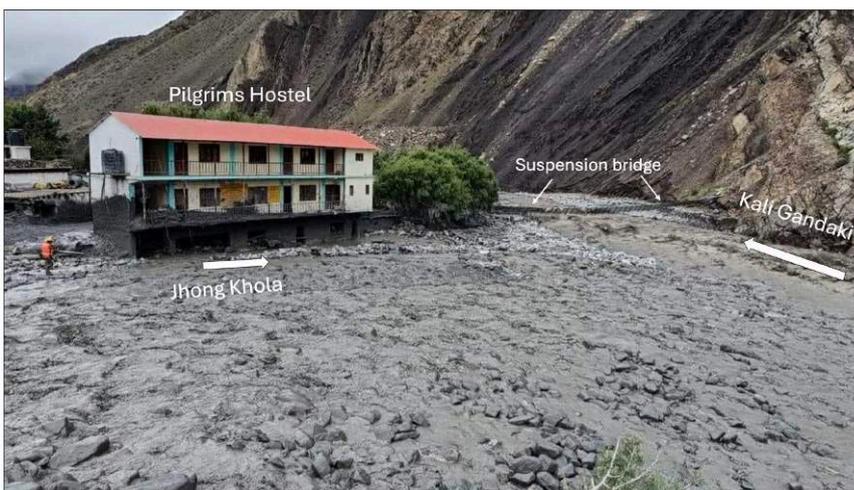
Fig. 15 – Impacts of the Jhong khola flood at the junction with the Kali Gandaki.

View taken the day after the flood, from the right bank terrace (+5 m) of the Jhong Khola, near the prayers wall leading to the Buddhist Monastery. Debris carried by the flood invaded the ground floor of the Pilgrims Hostel and impacted the first floor. The width of the Kali Gandaki was reduced, while the suspension bridge was severely damaged. It has since been repaired by Kadoorie AAA (photo: N. Gurung, August 14, 2023).

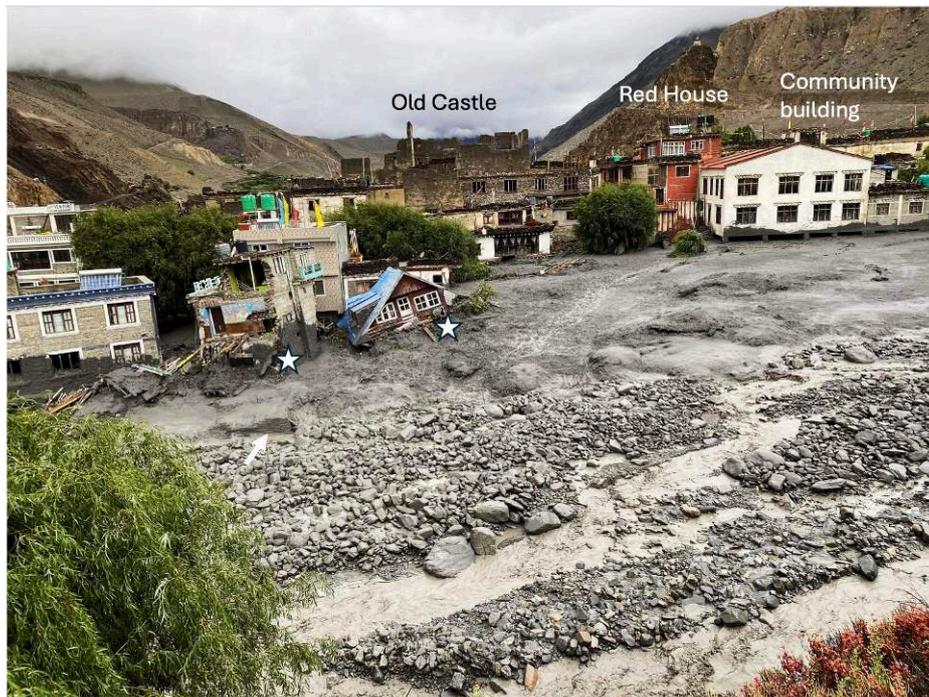
Fig. 16 – Impacts of the flood in Kagbeni.

View taken from the left bank terrace (+10 m) of the Jhong Khola, the next day after the flood (between sections 5 and 6, fig. 14B). The channel of the river is totally invisible: mud and coarse debris are spread over the former active flood plain. The lower floor of the community building has been very impacted as part of the flow passed by behind the trees. Further downstream, two buildings (with stars) have been destroyed, yet their position protected the houses situated behind them, which could be repaired: their owners are now living here again. The pillar of an old bridge (white arrow) is still present (photo: N. Gurung, August 14, 2023).

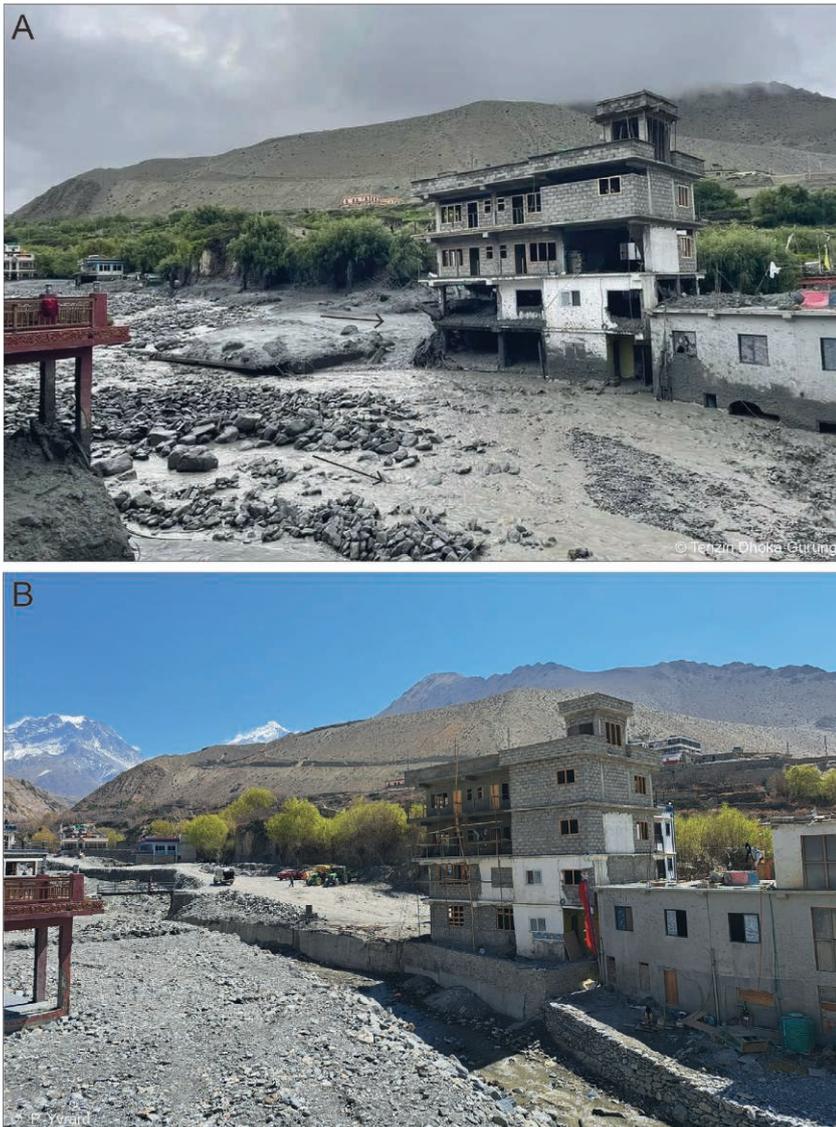
Fig. 17 – Impacts of the flood near the Johnny Cash hotel and restaurant, eastward and upstream view from the right bank. A: the situation the morning after the flood shows how the volume of debris has totally filled up the Jhong Khola channel and favored the flood spreading in adjacent street (see arrow behind the restaurant). The size of transported debris and blocks confirms the high density of the flow, and mud marks indicate the level reached by the flows (photo: Tenzin Dhoka Gurung, Aug. 14, 2023); B: some months later, the situation appears “normal”: the channelized Jhong Khola is visible again with its former cross section, part of the excavated debris has been deposited to re-create a lower terrace again, but the restaurant was still under repair (photo: P. Yvrard, March 12, 2024).

and the flood reached the 2nd floor of the building. The next morning (Aug. 14, 2023), the Jhong Khola channel was still not visible (fig. 17A), as the whole area was buried by flood debris of various sizes, including large blocks (> 1 m³) and dark mud (provided by the Spiti shales eroded from upstream). A few days after the flood, the Jhong Khola channel was cleaned off by locals,

retaining the same cross-section as before the flood (fig. 17B). It took more than a year to restore and reopen the Hotel-restaurant (fig. 18), even though it still overlooks the channel directly, with its foundations placed right in the riverbed, exactly as it was before the flood.

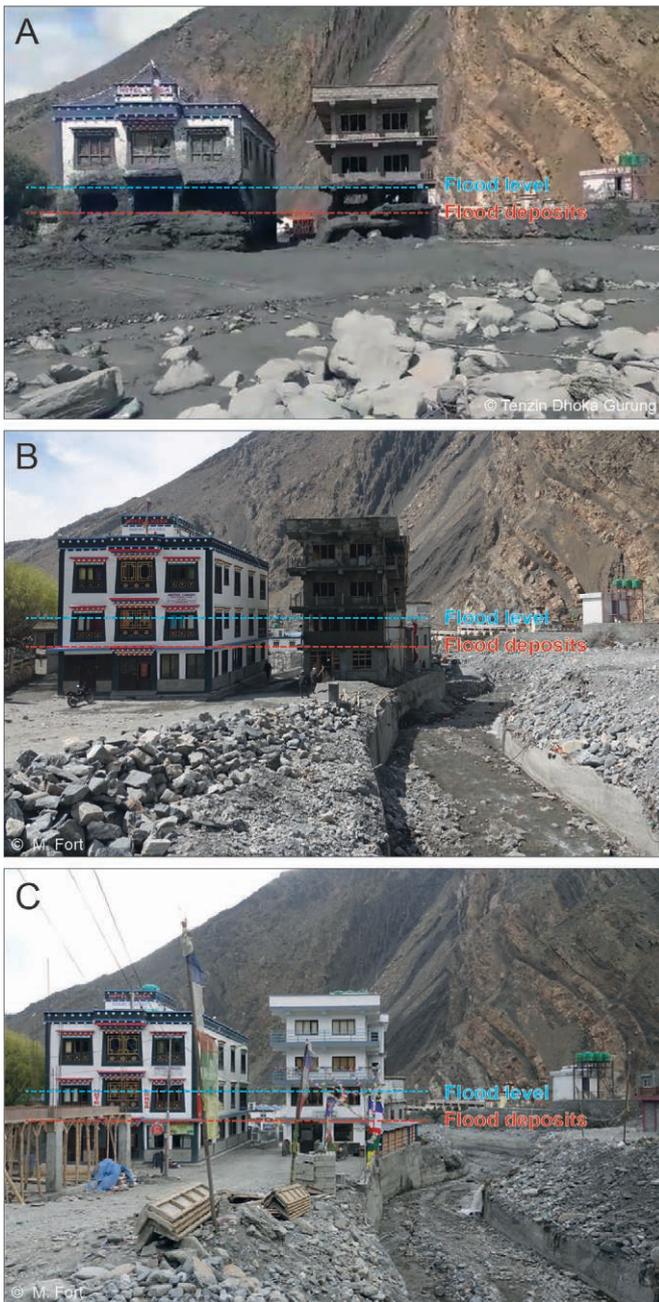
Fig. 18 – Post flood repair and reconstruction in Kagbeni village. A: the Lhasa Hotel and Johnny Cash Hotel and Restaurant, the next morning after the flood, without any Jhong Khola channel (photo: Tenzin Dhoka Gurung, Aug. 14, 2023); B: same view six months later, with the channelized riverbanks of Jhong Khola (discharge $< 1 \text{ m}^3/\text{s}$), and part of dug out debris remaining on both sides (photo: M. Fort, March 9, 2024); C: the Johnny Cash Hotel and Restaurant is re-opened, whereas a new building (washed away in August 2023) is under re-construction in front of the Lhasa Hotel (photo: M. Fort, March 13, 2025).

Close to the Johnny Cash Hotel, the less affected Lhasa hotel (left) was more rapidly repaired (in a few months; fig. 18A, B). Meanwhile, in March 2025, another building totally washed away in 2023 is being rebuilt in the same location, just in front of Lhasa hotel (fig. 18C).

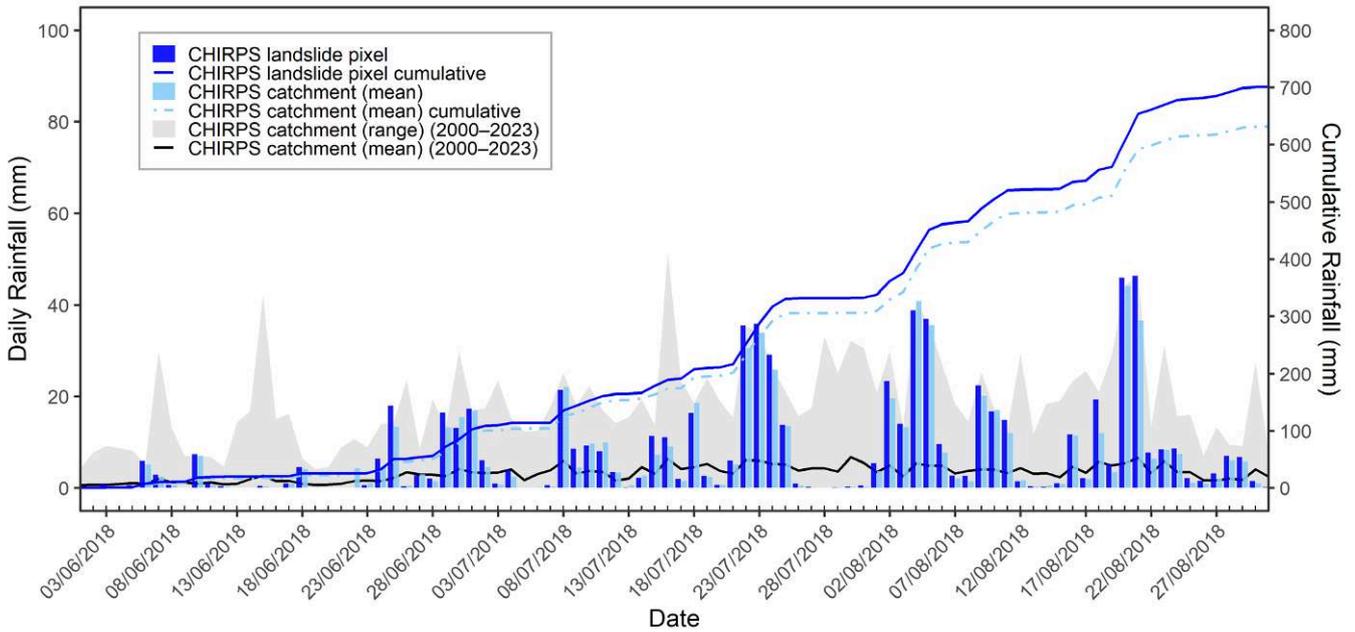
Fig. 19 – Daily rainfall of June-August 2018 based on CHIRPS 3.0 data.

CHIRPS 3.0 daily and cumulative rainfall for the CHIRPS pixel including the landslide site of 2023 as well as for the Jhong Khola catchment. In addition, mean daily rainfall and the range of daily rainfall (2000-2023) is shown based on CHIRPS data. Sources: CHIRPS 3.0: <https://www.chc.ucsb.edu/data/chirps3>

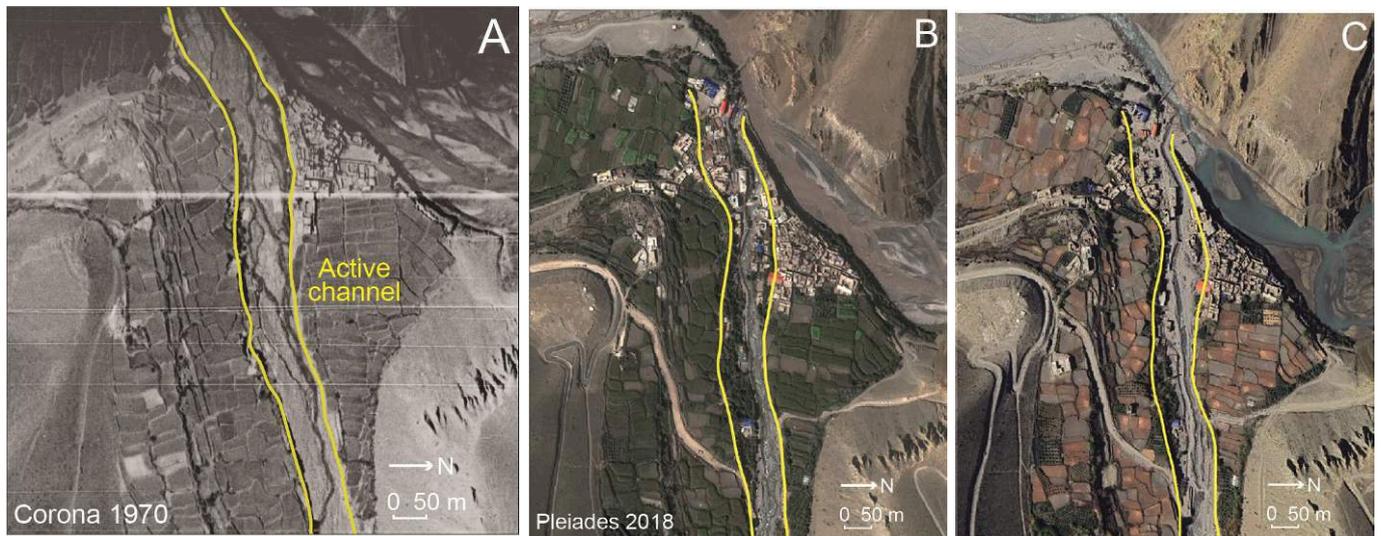
Fig. 20. Evolution (1970-2023) of the active floodplain of the Jhong Khola across Kagbeni. A: the traditional Kagbeni village is only developed on the northern edge of the junction with the Kali Gandaki: in 1970, the Jhong Khola has an active flood plain (outlined by yellow lines), with intermittent flows and transient gravel bars, all bounded by cultivated, lower terraces (source: Corona satellite images, Center for Advanced Spatial Technologies, University of Arkansas/U.S. Geological Survey); B: nearly fifty years later, the village has expanded mostly along the left bank of the Jhong Khola (source Pleiades), largely encroaching on the former active floodplain, especially close to the Kali Gandaki River junction where the dry road coming from the south ends (source: Pleiades satellite imagery, 2018); C: taken 3 months after the flood, this image clearly shows that during the flood the Jhong Khola reoccupied its natural, functional flooding space (source: Google Earth, Nov. 2023).
