From the Hydroclimatic Disaster to the Forced (Re)construction: Case Study of the Akatani Watershed in Japan [†]

Abstract: On 5–6 July 2017 (J17), an unusual series of rainfalls induced a concentration of precipitations in Northern Kyushu, Japan, reaching 516 mm in 24 h in Asakura City, a first in its history since the beginning of observation in 1976. This triggered unprecedented hydro-meteorological hazards (landslides, debris flows, and floods) in forested mountainous areas, such as in the Akatani watershed, where the estimated discharge reached 520 m³/s at its outflow. It induced numerous deaths, structural damages, destruction of river channels, and deposition of sediment in flood plains. If smaller-scale hazards have usually driven authorities to build protection systems in the watershed, the J17 crisis called for a full remodeling of it, interrupting waterways and reshaping slope shapes and structures. Considering the means deployed by the central government for this reconstruction, the J17 event triggered a full “re-construction” of rivers, modifying the hydrosystem’s functioning at the watershed scale. Thus, our objective is to show that after the relative stability of Ak

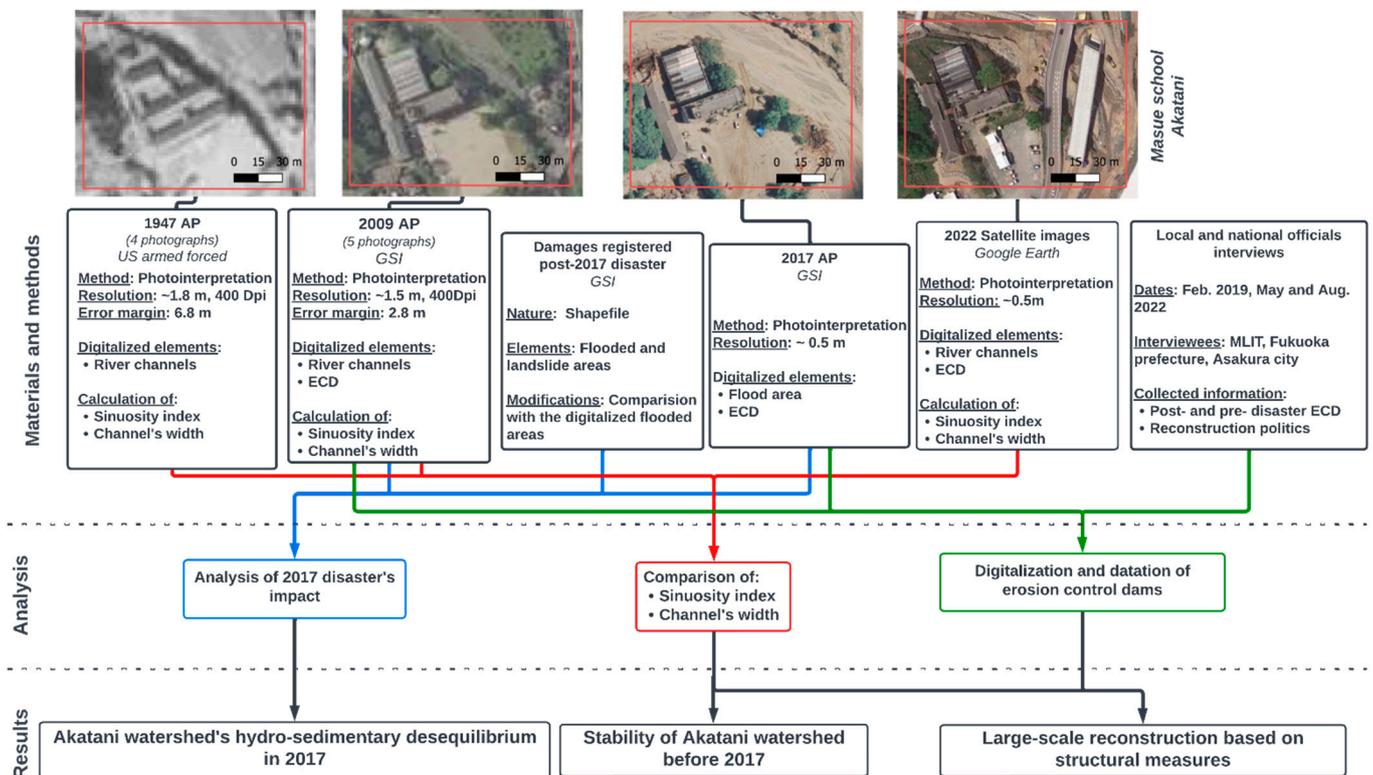
Figure 2. Diagram of the used methods and materials.

To highlight the J17 disaster’s impacts and follow reconstruction policies, we based the methodology on a diachronic analysis of multi-source imagery from 1947 to 2022 (Figure 2). To show the relative stability of the AK watershed before 2017 and the disequilibrium the J17 crisis caused, we analyzed the watershed’s evolution over 75 y by comparing the (i) river sinuosity index, (ii) channel width, and (iii) construction of erosion control structures (ECSs). These comparisons were made with manually georeferenced aerial photographs (APs) for 1947, 2009 [5], and 2017 [6] and 2022 satellite images (Figure 2). Aps mainly cover the AK watershed area, with a focus on valley bottoms. Due to the physiography of the area, we used the polynomial 2 function for the georeferencing. We accepted a margin error of 1 to 2 pixels for each georeferenced AP. We used 2017 and 2022 images to georeference the 2009 APs. Due to the similarity of land use, we georeferenced the 1947 APs with the help of 1980s APs [6]. Margin errors are most important for 1947, due to the bad quality of the photos.

With 1947, 2009, 2017, and 2022 resources, we digitalized river channels and ECDs (Figure 2). Because of the chosen method, errors may occur in the digitalization process. To calculate the margin error of the digitalized elements, we used two disconnected channels visible in 2022’s images (Figure 3). Every 15 m, we calculated and merged the difference between pre-disaster and disconnected channels for each bank (Figure 3). Errors may be due to the vegetation along rivers, limits of photointerpretation, or mismatches during the georeferencing process. To identify rivers’ modification, we calculated their width and sinuosity index for 3 periods (Figure 2). The following thresholds characterize the sinuosity indexes: <1.05: straight; 1.05–1.3: sinuous; 1.3–1.5: moderate meandering; >1.5: meandering form [7]. For their width, we calculated the mean length from one bank to the other with transects every 100 m.

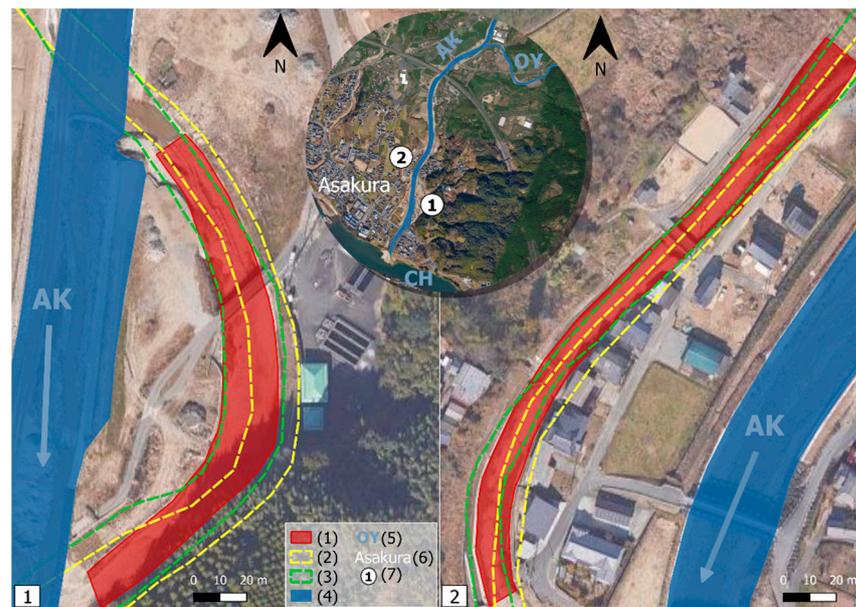
Figure 3. Example of remaining channels used to calculate margin errors. (1) Disconnected channel; (2) 1947 channel; (3) 2009 channel; (4) 2022 channel; (5) hydronym; (6) toponym; (7) channel location.

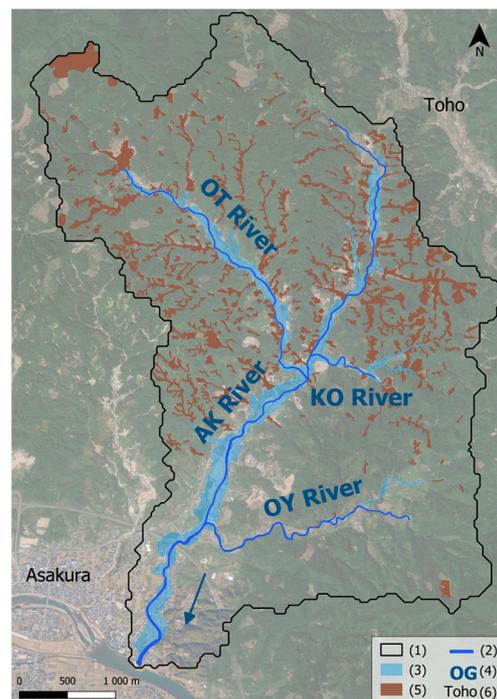
Figure 4. Spatial coverage of hydroclimatic hazards after the heavy rainfall of the J17 event. (1) AK watershed area; (2) 2009 channel; (3) 2017 flood [11]; (4) hydronym; (5) landslide area [11]; (6) toponym.

Heavy rainfalls concentrated in a short period of time such as the J17 event are rare in the AK watershed [2]. The Kyushu Regional Management Service Association (KRMSA) has registered significant disasters, such as hydroclimatic-related ones, since 679 for the Fukuoka prefecture. Very few registered events explicitly involve the AK watershed: one in 1921 and the J17 one [8]. This shows that hydro-meteorological hazards rarely trigger high-magnitude disasters in the watershed, strengthening the singularity of the J17 disaster. The AK watershed registered significant damages in 2017. In the mountains, landslides and debris flows were triggered in several sub-basins, carrying driftwood (Figure 4) [9]. Downstream, river floods inundated valley bottoms, carrying sediments from the upper slope erosion. In addition to the deaths, these hazards damaged building and transportation systems in the AK watershed [10].

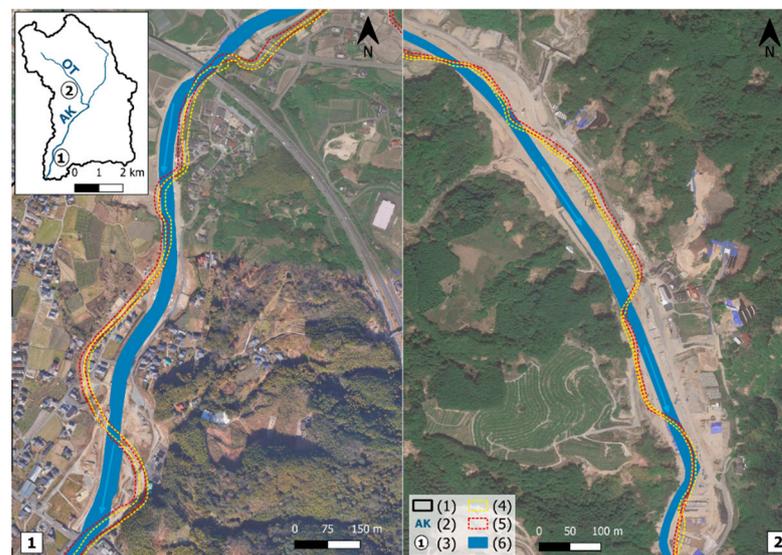
Figure 5. Close-up of sinuosity index evolution. (1) AK watershed; (2) hydronym; (3) close-up location; (4) 1947 channel; (5) 2009 channel; (6) 2022 channel.

In 1947, with a sinuosity index exceeding 1.05, channels were sinuous (Table 2). The AK downstream is the one with the highest sinuosity index (1.11), which may be due to its location in lowlands, while the other sections are in mountainous areas with narrow

valley bottoms. In 2009, three of them remained sinuous (Table 2). The upstream part of the AK channel is the only one considered straight, with a sinuosity index less than 1.05. The highest indexes are for the downstream of the AK (1.10) and OT (1.07) channels. In 2022, a real shift in their sinuosity occurred, with all rates below 1.05. The AK downstream sinuosity index decreased the most, from 1.10 to 1.03 (Table 2). Figure 5 illustrates this straightening process in the AK downstream and OT. While the rivers' paths were mainly similar in 1947 and 2009, the 2022 channels show an abrupt change.

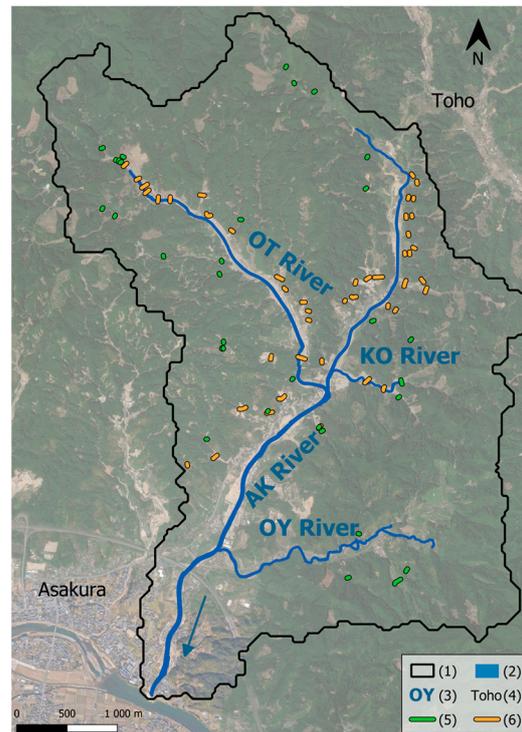
Figure 6. ECDs constructed in the AK watershed before and after 2017. (1) AK watershed area; (2) 2022 channels; (3) hydronym; (4) toponym; (5) pre-2017 dams; (6) post-2017 dams.

In addition to remodeling valley bottoms, the government added ECSs. Erosion control was valorized by governmental actors in the process of AK watershed reconstruction. Before 2017, there were 33 dams (Figure 6). Among them, 27 were managed by the MAFF and only 6 of them by the prefecture. After 2017, the central government planned the construction of 30 new sabo dams and the MAFF constructed 15 more chisan dams (Figure 6). In total, we inventoried 78 ECDs in the watershed in 2022. Between 2017 and 2022, the number of sabo dams was thus multiplied by 5.

ECDs are located in mountainous areas, and 92% of them were constructed in the AK or OT watersheds. New constructions are closer to valley bottoms than the pre-disaster ones (Figure 6). In the OT river, many sabo dams are at the outflow of mountainous subwatersheds [13]. Here, two main types of sabo dams were constructed: (i) closed-type dams, storing sediments, and (ii) slit dams, which catch large-scale debris and allow flow to circulate (Figure 7).

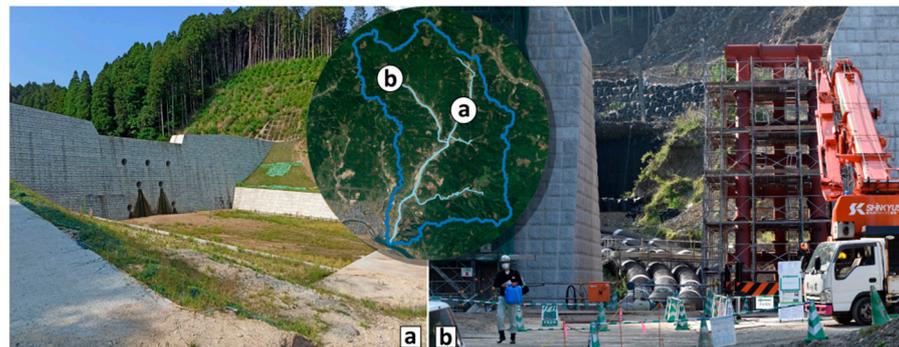
Figure 7. Illustration of the sabo dam constructed in the AK River. (a) Closed-type sabo dam AK16, ©M. Dumont, 2022; (b) slit-type sabo dam OT15-6, ©V. Siccard, 2022.

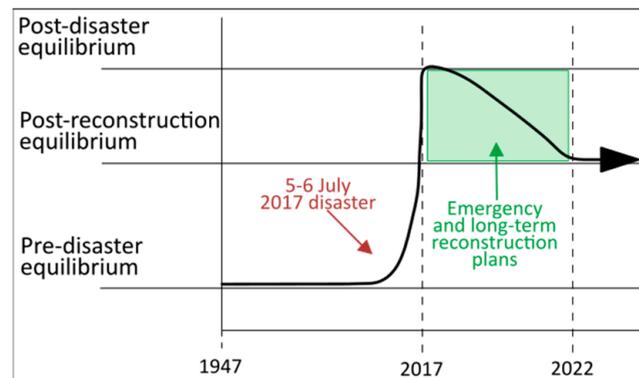
Figure 8. Dynamic of AK watershed’s rivers. Adapted from Chorley and Kennedy (1971) [14].

The J17 disaster can be considered as an LFHM hydroclimatic event. The disruption induced a different equilibrium from the previously existing one. Right after the crisis, aerial images showed a new river equilibrium with partly destroyed river channels and an evolution of river style from single channels to braided ones. However, because of the necessity of reconstruction of the AK watershed, a new equilibrium was designed by the Japanese government. With the enlargement and the straightening of their channels, rivers are reaching a new balance between the pre- and post-disaster ones (Figure 8).
